# Access Compliance Report

## Public Rights-of-Way

### (Curb Ramps)

Intersection ID: 11102	Main Street: TUCKASEEGEE_RD	Cross Street: JAY_ST	Location: SW
ADA ID: C2E906887077	Ramp Type: PerpDiag	Initial Pass/Fail: Fail	Overall Compliance: No
Severity Score: 22.5			
Codes/Mitigation Info/Possible Solution		Field Measurements/Component Compliance

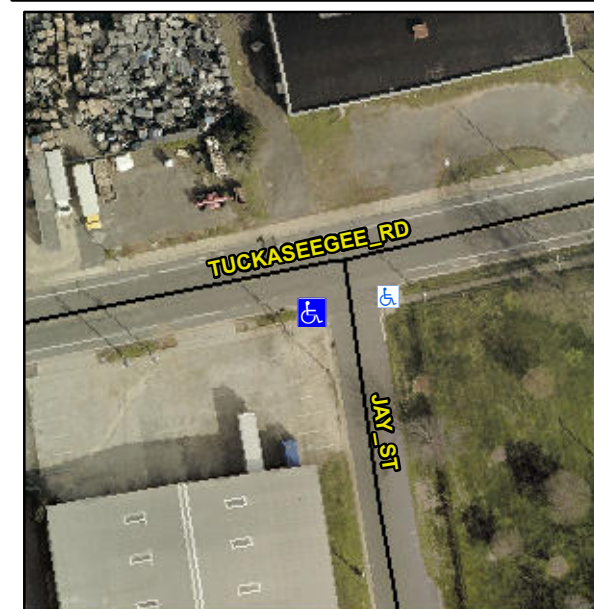
**Not Found, R304.5.1, R304.2.2, R304.5.3**

Compliance	Description	Data	Compliance	Description	Data
N/A	Ramp Length (in)	61.5	No	Ramp Slope (%)	9.3
No	Ramp Width (in)	46.5	No	Ramp XSlope (%)	2.6
N/A	Flare Type LT	N/A	N/A	Flare Type RT	N/A
N/A	Flare Slope LT (%)	N/A	N/A	Flare Slope RT (%)	N/A
N/A	Flare Traversable LT?	N/A	N/A	Flare Traversable RT?	N/A
N/A	Landing Length (in)	N/A	N/A	DWS Provided?	N/A
N/A	Landing Width (in)	N/A	N/A	DWS Contrast?	N/A
N/A	Landing Slope (%)	N/A	N/A	DWS Length (in)	N/A
N/A	Landing X Slope (%)	N/A	N/A	DWS Full Width?	N/A
N/A	Landing Curb? (Y/N)	N/A	N/A	DWS Offset (in)	N/A
N/A	Shared Landing?	N/A			
N/A	Gutter Ponding?	N/A	N/A	Gutter Slope (%)	N/A
N/A	Gutter Lip Ht (in)	N/A	N/A	Gutter X Slope (%)	N/A
N/A	Painted X Walk1?	No	N/A	Painted X Walk2?	No
	X Walk 1 Direction	To E		X Walk 2 Direction	To N
N/A	X Walk 1 Width (in)	N/A	N/A	X Walk 2 Width (in)	N/A
	X Walk 1 Slope (%)	0.3		X Walk 2 Slope (%)	2.0
	X Walk 1 X Slope (%)	0.6		X Walk 2 X Slope (%)	0.1

N/A	Ramp inside XWalk1?	N/A	N/A	Ramp inside XWalk2?	N/A
	Road Slope (%)	3.6	N/A	Clear Space?	N/A
	Road X Slope (%)	0.3	N/A	Clear Space to XWalk (in)	N/A
N/A	Any Obstructions?	N/A	N/A	Storm Grate/Utility Hazard?	N/A
	Obstruction Type			Storm Grate/Utility Type	
		N/A			N/A
			Yes	Surface Condition? (G/P)	Good

**Remove & Replace Curb Ramp With Two New Directional Ramps or Equivalent.**
