Access Compliance Report

Public Rights-of-Way

(Curb Ramps)

Intersection ID: 2901	Main Street: CRAGLAND_CT	Cross Street: HARBURN_FOREST_DR	Location: NW
ADA ID: C2EAEBD9E102	Ramp Type: PerpDiag	Initial Pass/Fail: Fail	Overall Compliance: No
Severity Score: 25			
Codes/Mitigation Info/Possible Solution		Field Measurements/Component Compliance

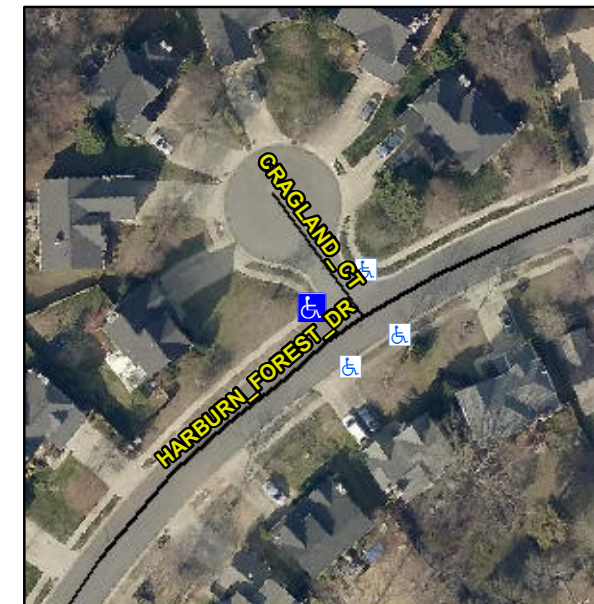
Compliance	Description	Data	Compliance	Description	Data
N/A	Ramp Length (in)	47.0	No	Ramp Slope (%)	12.5
Yes	Ramp Width (in)	48.0	Yes	Ramp XSlope (%)	1.1
N/A	Flare Type LT	N/A	N/A	Flare Type RT	N/A
N/A	Flare Slope LT (%)	N/A	N/A	Flare Slope RT (%)	N/A
N/A	Flare Traversable LT?	N/A	N/A	Flare Traversable RT?	N/A
N/A	Landing Length (in)	N/A	N/A	DWS Provided?	N/A
N/A	Landing Width (in)	N/A	N/A	DWS Contrast?	N/A
N/A	Landing Slope (%)	N/A	N/A	DWS Length (in)	N/A
N/A	Landing X Slope (%)	N/A	N/A	DWS Full Width?	N/A
N/A	Landing Curb? (Y/N)	N/A	N/A	DWS Offset (in)	N/A
N/A	Shared Landing?	N/A			
N/A	Gutter Ponding?	N/A	N/A	Gutter Slope (%)	N/A
N/A	Gutter Lip Ht (in)	N/A	N/A	Gutter X Slope (%)	N/A
N/A	Painted X Walk1?	No	N/A	Painted X Walk2?	No
	X Walk 1 Direction	To S		X Walk 2 Direction	To E
N/A	X Walk 1 Width (in)	N/A	N/A	X Walk 2 Width (in)	N/A
	X Walk 1 Slope (%)	3.5		X Walk 2 Slope (%)	2.1
	X Walk 1 X Slope (%)	1.8		X Walk 2 X Slope (%)	1.4

N/A	Ramp inside XWalk1?	N/A	N/A	Ramp inside XWalk2?	N/A
	Road Slope (%)	1.7	N/A	Clear Space?	N/A
	Road X Slope (%)	2.0	N/A	Clear Space to XWalk (in)	N/A
N/A	Any Obstructions?	N/A	N/A	Storm Grate/Utility Hazard?	N/A
	Obstruction Type			Storm Grate/Utility Type	
		N/A			N/A
			Yes	Surface Condition? (G/P)	Good

Possible Solutions:

Remove & Replace Curb Ramp With Two New Directional Ramps or Equivalent.
