Access Compliance Report

Public Rights-of-Way

(Curb Ramps)

Intersection ID: N/A	Main Street: YORK_CENTER	Cross Street: N/A	Location: NW
ADA ID: C2EE455B918C	Ramp Type: PerpDiag	Initial Pass/Fail: Fail	Overall Compliance: No
		Severity Score: 12.5

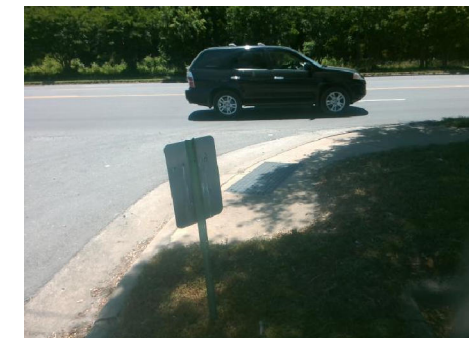
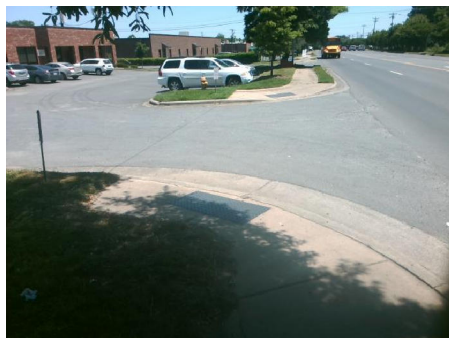
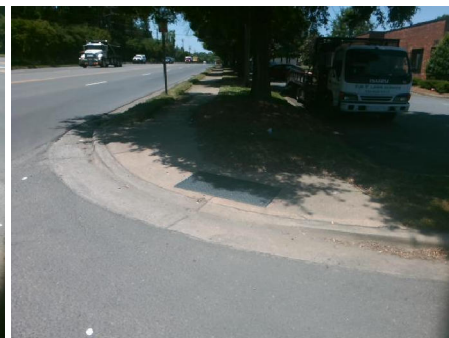
Not Found, R304.5.3

Compliance	Description	Data	Compliance	Description	Data
N/A	Ramp Length (in)	71.0	Yes	Ramp Slope (%)	7.5
Yes	Ramp Width (in)	50.0	No	Ramp XSlope (%)	6.4
N/A	Flare Type LT	N/A	N/A	Flare Type RT	N/A
N/A	Flare Slope LT (%)	N/A	N/A	Flare Slope RT (%)	N/A
N/A	Flare Traversable LT?	N/A	N/A	Flare Traversable RT?	N/A
N/A	Landing Length (in)	N/A	N/A	DWS Provided?	N/A
N/A	Landing Width (in)	N/A	N/A	DWS Contrast?	N/A
N/A	Landing Slope (%)	N/A	N/A	DWS Length (in)	N/A
N/A	Landing X Slope (%)	N/A	N/A	DWS Full Width?	N/A
N/A	Landing Curb? (Y/N)	N/A	N/A	DWS Offset (in)	N/A
N/A	Shared Landing?	N/A			
N/A	Gutter Ponding?	N/A	N/A	Gutter Slope (%)	N/A
N/A	Gutter Lip Ht (in)	N/A	N/A	Gutter X Slope (%)	N/A
N/A	Painted X Walk1?	No	N/A	Painted X Walk2?	No
	X Walk 1 Direction	To S		X Walk 2 Direction	To E
N/A	X Walk 1 Width (in)	N/A	N/A	X Walk 2 Width (in)	N/A
	X Walk 1 Slope (%)	1.1		X Walk 2 Slope (%)	1.1
	X Walk 1 X Slope (%)	0.4		X Walk 2 X Slope (%)	4.6

N/A	Ramp inside XWalk1?	N/A	N/A	Ramp inside XWalk2?	N/A
	Road Slope (%)	5.3	N/A	Clear Space?	N/A
	Road X Slope (%)	1.5	N/A	Clear Space to XWalk (in)	N/A
N/A	Any Obstructions?	N/A	N/A	Storm Grate/Utility Hazard?	N/A
	Obstruction Type			Storm Grate/Utility Type	
		N/A			N/A
		Yes		Surface Condition? (G/P)	Good

Remove & Replace Curb Ramp With Two New Directional Ramps or Equivalent.

Total Cost: \$ 3200.00
