Access Compliance Report

Public Rights-of-Way

(Curb Ramps)

Intersection ID: 11444		Main Street: ALLEGHANY_ST		Cross Street: MCKINLEY_DR		Location: SE			
ADA ID: C2F4C88608FB		Ramp Type: Perp		Initial Pass/Fail: Fail		Overall Compliance: No		Severity Score: 22.5	
Codes/Mitigation Info/Possible Solution					Field Measurements/Component Compliance

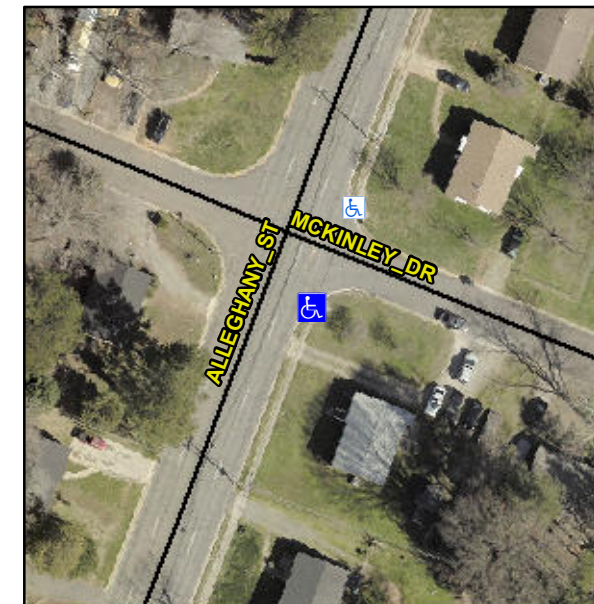
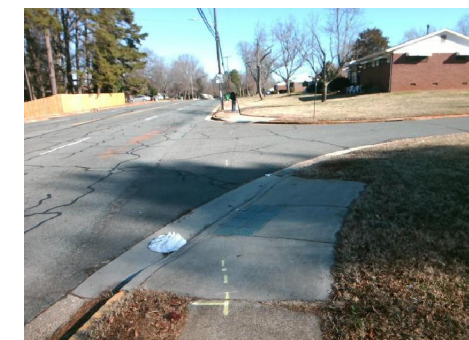
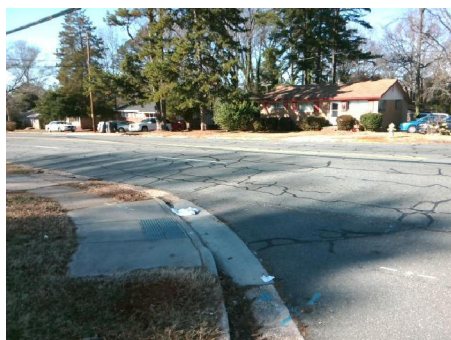
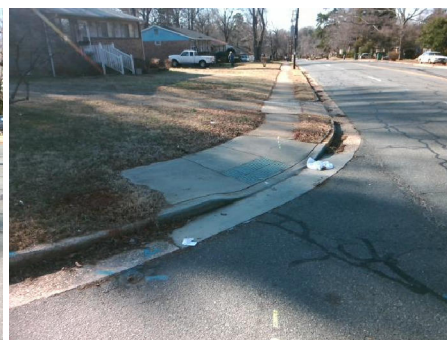
Not Found, R304.5.1, R304.2.2, R304.5.3

Compliance	Description	Data	Compliance	Description	Data
N/A	Ramp Length (in)	69.0	No	Ramp Slope (%)	8.8
No	Ramp Width (in)	44.5	No	Ramp XSlope (%)	3.6
N/A	Flare Type LT	N/A	N/A	Flare Type RT	N/A
N/A	Flare Slope LT (%)	N/A	N/A	Flare Slope RT (%)	N/A
N/A	Flare Traversable LT?	N/A	N/A	Flare Traversable RT?	N/A
N/A	Landing Length (in)	N/A	N/A	DWS Provided?	N/A
N/A	Landing Width (in)	N/A	N/A	DWS Contrast?	N/A
N/A	Landing Slope (%)	N/A	N/A	DWS Length (in)	N/A
N/A	Landing X Slope (%)	N/A	N/A	DWS Full Width?	N/A
N/A	Landing Curb? (Y/N)	N/A	N/A	DWS Offset (in)	N/A
N/A	Shared Landing?	N/A			
N/A	Gutter Ponding?	N/A	N/A	Gutter Slope (%)	N/A
N/A	Gutter Lip Ht (in)	N/A	N/A	Gutter X Slope (%)	N/A
N/A	Painted X Walk1?	No	N/A	Painted X Walk2?	N/A
	X Walk 1 Direction	To NE		X Walk 2 Direction	N/A
N/A	X Walk 1 Width (in)	N/A	N/A	X Walk 2 Width (in)	N/A
	X Walk 1 Slope (%)	5.8		X Walk 2 Slope (%)	N/A
	X Walk 1 X Slope (%)	0.9		X Walk 2 X Slope (%)	N/A

N/A	Ramp inside XWalk1?	N/A	N/A	Ramp inside XWalk2?	N/A
	Road Slope (%)	N/A	N/A	Clear Space?	N/A
	Road X Slope (%)	N/A	N/A	Clear Space to XWalk (in)	N/A
N/A	Any Obstructions?	N/A	N/A	Storm Grate/Utility Hazard?	N/A
	Obstruction Type			Storm Grate/Utility Type	
		N/A			N/A
			Yes	Surface Condition? (G/P)	Good

Possible Solutions:

Remove & Replace Entire Ramp.
