# Access Compliance Report

## Public Rights-of-Way

### (Curb Ramps)

| Intersection ID: 51704 | Main Street: IKEA_BV | Cross Street: BROOKSIDE_LN | Location: NW |

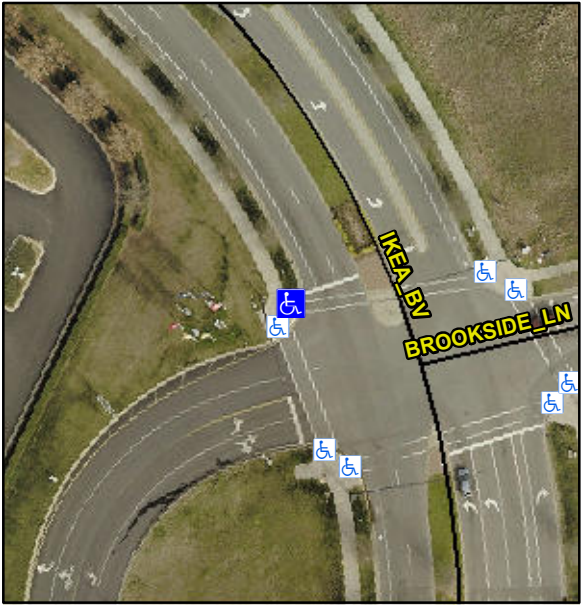
| ADA ID: C30867EA8A6D | Ramp Type: Perp | Initial Pass/Fail: Fail | Overall Compliance: No |
| | | Severity Score: 8.75 | |

| Codes/Mitigation Info/Possible Solution | | | Field Measurements/Component Compliance | | | |
|---|--|--|---|---|---|---|
| | | | N/A | Ramp Length (in) | 102.0 | Yes |
| | | | No | Ramp Width (in) | 46.5 | Yes |
| <p>Surveyor Notes:</p> <p><b>N/A</b></p> <p>PROW/ADA:</p> <p><b>Not Found, R304.5.1</b></p> | | | N/A | Flare Type RT | N/A | N/A |

| Codes/Mitigation Info/Possible Solution | | | Field Measurements/Component Compliance | | | |
|---|--|--|---|---|---|---|
| | <b>Remove &amp; Replace Entire Ramp.</b> | | <b>Description</b> | | | <b>Description</b> |
| Total Cost: | | | \$ | 1850.00 | | N/A |
