# Access Compliance Report

## Public Rights-of-Way

### (Curb Ramps)

Intersection ID: 13780	Main Street: ELIZABETH_AV	Cross Street: N_TORRENCE_ST	Location: S
ADA ID: C31EA426F308	Ramp Type: Perp	Initial Pass/Fail: Fail	Overall Compliance: No
Severity Score: 12.5			
Codes/Mitigation Info/Possible Solution		Field Measurements/Component Compliance

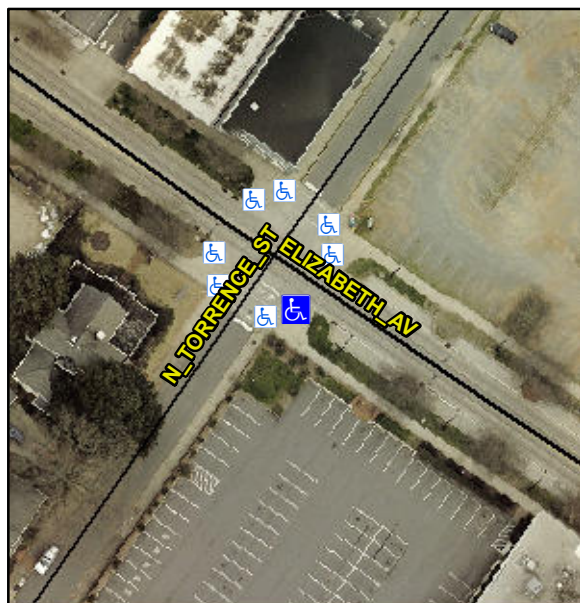
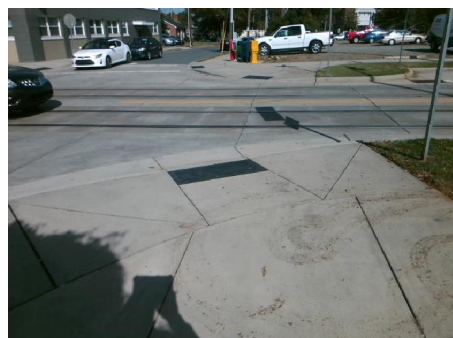
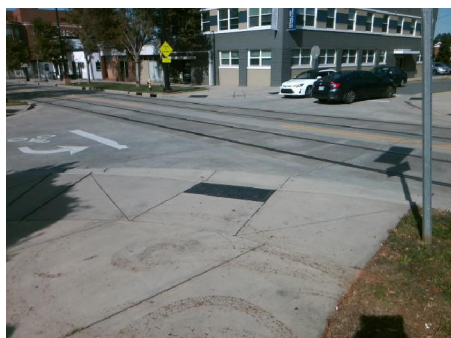
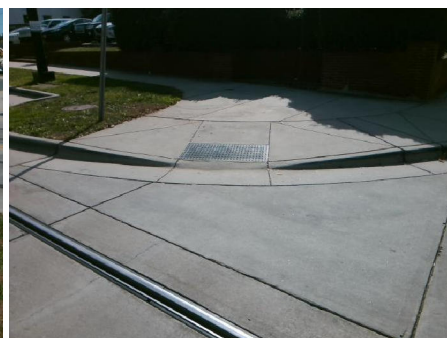
**Not Found, R304.2.2**

Compliance	Description	Data	Compliance	Description	Data
N/A	Ramp Length (in)	72.0	No	Ramp Slope (%)	9.8
Yes	Ramp Width (in)	48.0	Yes	Ramp XSlope (%)	1.1
N/A	Flare Type LT	N/A	N/A	Flare Type RT	N/A
N/A	Flare Slope LT (%)	N/A	N/A	Flare Slope RT (%)	N/A
N/A	Flare Traversable LT?	N/A	N/A	Flare Traversable RT?	N/A
N/A	Landing Length (in)	N/A	N/A	DWS Provided?	N/A
N/A	Landing Width (in)	N/A	N/A	DWS Contrast?	N/A
N/A	Landing Slope (%)	N/A	N/A	DWS Length (in)	N/A
N/A	Landing X Slope (%)	N/A	N/A	DWS Full Width?	N/A
N/A	Landing Curb? (Y/N)	N/A	N/A	DWS Offset (in)	N/A
N/A	Shared Landing?	N/A			
N/A	Gutter Ponding?	N/A	N/A	Gutter Slope (%)	N/A
N/A	Gutter Lip Ht (in)	N/A	N/A	Gutter X Slope (%)	N/A
N/A	Painted X Walk1?	No	N/A	Painted X Walk2?	N/A
	X Walk 1 Direction	To NE		X Walk 2 Direction	N/A
N/A	X Walk 1 Width (in)	N/A	N/A	X Walk 2 Width (in)	N/A
	X Walk 1 Slope (%)	1.5		X Walk 2 Slope (%)	N/A
	X Walk 1 X Slope (%)	3.4		X Walk 2 X Slope (%)	N/A

N/A	Ramp inside XWalk1?	N/A	N/A	Ramp inside XWalk2?	N/A
	Road Slope (%)	N/A	N/A	Clear Space?	N/A
	Road X Slope (%)	N/A	N/A	Clear Space to XWalk (in)	N/A
N/A	Any Obstructions?	N/A	N/A	Storm Grate/Utility Hazard?	N/A
	Obstruction Type			Storm Grate/Utility Type	
		N/A			N/A
			Yes	Surface Condition? (G/P)	Good

**Remove & Replace Entire Ramp.**
