Access Compliance Report

Public Rights-of-Way

(Curb Ramps)

Intersection ID: 13382	Main Street: E_CATHERINE_ST	Cross Street: S_COLLEGE_ST	Location: S
ADA ID: C31F1A594FC1	Ramp Type: Perp	Initial Pass/Fail: Fail	Overall Compliance: No
Severity Score: 13.75			
Codes/Mitigation Info/Possible Solution		Field Measurements/Component Compliance

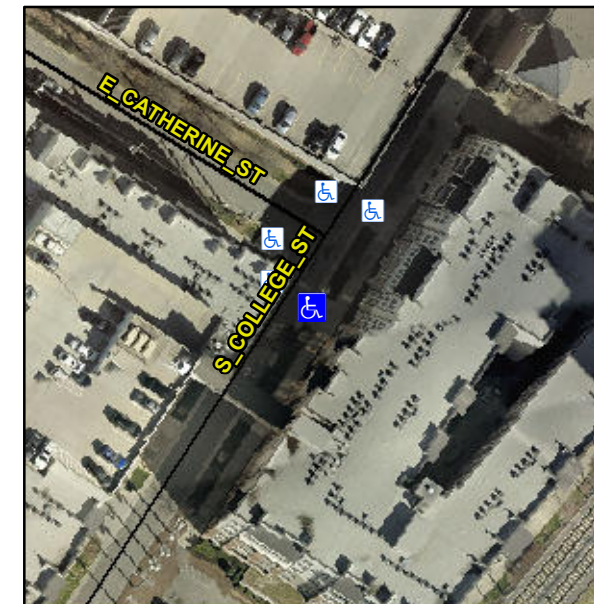
PROW/ADA:

Not Found, R304.2.2

Compliance	Description	Data	Compliance	Description	Data
N/A	Ramp Length (in)	95.5	No	Ramp Slope (%)	10.0
Yes	Ramp Width (in)	48.0	Yes	Ramp XSlope (%)	3.2
N/A	Flare Type LT	N/A	N/A	Flare Type RT	N/A
N/A	Flare Slope LT (%)	N/A	N/A	Flare Slope RT (%)	N/A
N/A	Flare Traversable LT?	N/A	N/A	Flare Traversable RT?	N/A
N/A	Landing Length (in)	N/A	N/A	DWS Provided?	N/A
N/A	Landing Width (in)	N/A	N/A	DWS Contrast?	N/A
N/A	Landing Slope (%)	N/A	N/A	DWS Length (in)	N/A
N/A	Landing X Slope (%)	N/A	N/A	DWS Full Width?	N/A
N/A	Landing Curb? (Y/N)	N/A	N/A	DWS Offset (in)	N/A
N/A	Shared Landing?	N/A			
N/A	Gutter Ponding?	N/A	N/A	Gutter Slope (%)	N/A
N/A	Gutter Lip Ht (in)	N/A	N/A	Gutter X Slope (%)	N/A
N/A	Painted X Walk1?	No	N/A	Painted X Walk2?	N/A
	X Walk 1 Direction	To NW		X Walk 2 Direction	N/A
N/A	X Walk 1 Width (in)	N/A	N/A	X Walk 2 Width (in)	N/A
	X Walk 1 Slope (%)	2.8		X Walk 2 Slope (%)	N/A
	X Walk 1 X Slope (%)	4.6		X Walk 2 X Slope (%)	N/A

N/A	Ramp inside XWalk1?	N/A	N/A	Ramp inside XWalk2?	N/A
	Road Slope (%)	N/A	N/A	Clear Space?	N/A
	Road X Slope (%)	N/A	N/A	Clear Space to XWalk (in)	N/A
N/A	Any Obstructions?	N/A	N/A	Storm Grate/Utility Hazard?	N/A
	Obstruction Type			Storm Grate/Utility Type	
		N/A			N/A
			Yes	Surface Condition? (G/P)	Good

Possible Solutions:

Remove & Replace Entire Ramp.
