Access Compliance Report

Public Rights-of-Way

(Curb Ramps)

Intersection ID: 15989	Main Street: S_TRYON_ST	Cross Street: YORKSHIRE_DR	Location: S
ADA ID: C3209CABB5D1	Ramp Type: PerpDiag	Initial Pass/Fail: Fail	Overall Compliance: No
		Severity Score: 10

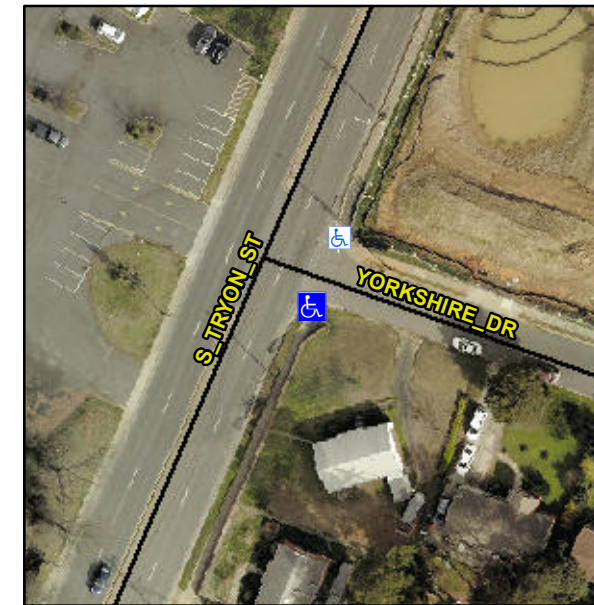
Not Found, R304.5.1, R304.5.3

Compliance	Description	Data	Compliance	Description	Data
N/A	Ramp Length (in)	119.0	Yes	Ramp Slope (%)	5.4
No	Ramp Width (in)	40.0	No	Ramp XSlope (%)	3.2
N/A	Flare Type LT	N/A	N/A	Flare Type RT	N/A
N/A	Flare Slope LT (%)	N/A	N/A	Flare Slope RT (%)	N/A
N/A	Flare Traversable LT?	N/A	N/A	Flare Traversable RT?	N/A
N/A	Landing Length (in)	N/A	N/A	DWS Provided?	N/A
N/A	Landing Width (in)	N/A	N/A	DWS Contrast?	N/A
N/A	Landing Slope (%)	N/A	N/A	DWS Length (in)	N/A
N/A	Landing X Slope (%)	N/A	N/A	DWS Full Width?	N/A
N/A	Landing Curb? (Y/N)	N/A	N/A	DWS Offset (in)	N/A
N/A	Shared Landing?	N/A			
N/A	Gutter Ponding?	N/A	N/A	Gutter Slope (%)	N/A
N/A	Gutter Lip Ht (in)	N/A	N/A	Gutter X Slope (%)	N/A
N/A	Painted X Walk1?	No	N/A	Painted X Walk2?	No
	X Walk 1 Direction	To NE		X Walk 2 Direction	To NW
N/A	X Walk 1 Width (in)	N/A	N/A	X Walk 2 Width (in)	N/A
	X Walk 1 Slope (%)	3.5		X Walk 2 Slope (%)	1.4
	X Walk 1 X Slope (%)	1.0		X Walk 2 X Slope (%)	2.1

N/A	Ramp inside XWalk1?	N/A	N/A	Ramp inside XWalk2?	N/A
	Road Slope (%)	1.2	N/A	Clear Space?	N/A
	Road X Slope (%)	3.6	N/A	Clear Space to XWalk (in)	N/A
N/A	Any Obstructions?	N/A	N/A	Storm Grate/Utility Hazard?	N/A
	Obstruction Type			Storm Grate/Utility Type	
		N/A			N/A
		Yes		Surface Condition? (G/P)	Good

Remove & Replace Curb Ramp With Two New Directional Ramps or Equivalent.
