Access Compliance Report

Public Rights-of-Way

(Curb Ramps)

Intersection ID: 9707	Main Street: BRAWLEY_LN	Cross Street: STONE_ABBEY_PL	Location: SW
ADA ID: C328772183B8	Ramp Type: Perp	Initial Pass/Fail: Fail	Overall Compliance: No
			Severity Score: 21.25

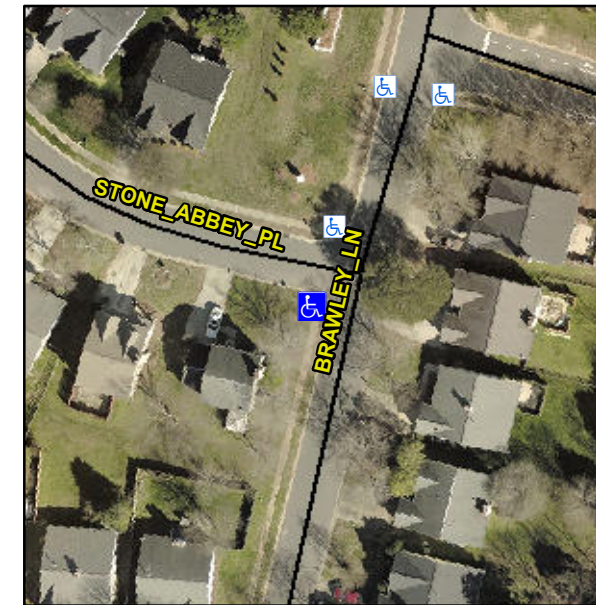
Not Found, R304.5.1, R304.2.2

Compliance	Description	Data	Compliance	Description	Data
N/A	Ramp Length (in)	68.0	No	Ramp Slope (%)	9.7
No	Ramp Width (in)	47.5	Yes	Ramp XSlope (%)	1.4
N/A	Flare Type LT	N/A	N/A	Flare Type RT	N/A
N/A	Flare Slope LT (%)	N/A	N/A	Flare Slope RT (%)	N/A
N/A	Flare Traversable LT?	N/A	N/A	Flare Traversable RT?	N/A
N/A	Landing Length (in)	N/A	N/A	DWS Provided?	N/A
N/A	Landing Width (in)	N/A	N/A	DWS Contrast?	N/A
N/A	Landing Slope (%)	N/A	N/A	DWS Length (in)	N/A
N/A	Landing X Slope (%)	N/A	N/A	DWS Full Width?	N/A
N/A	Landing Curb? (Y/N)	N/A	N/A	DWS Offset (in)	N/A
N/A	Shared Landing?	N/A			
N/A	Gutter Ponding?	N/A	N/A	Gutter Slope (%)	N/A
N/A	Gutter Lip Ht (in)	N/A	N/A	Gutter X Slope (%)	N/A
N/A	Painted X Walk1?	No	N/A	Painted X Walk2?	N/A
	X Walk 1 Direction	To NE		X Walk 2 Direction	N/A
N/A	X Walk 1 Width (in)	N/A	N/A	X Walk 2 Width (in)	N/A
	X Walk 1 Slope (%)	0.4		X Walk 2 Slope (%)	N/A
	X Walk 1 X Slope (%)	0.3		X Walk 2 X Slope (%)	N/A

N/A	Ramp inside XWalk1?	N/A	N/A	Ramp inside XWalk2?	N/A
	Road Slope (%)	N/A	N/A	Clear Space?	N/A
	Road X Slope (%)	N/A	N/A	Clear Space to XWalk (in)	N/A
N/A	Any Obstructions?	N/A	N/A	Storm Grate/Utility Hazard?	N/A
	Obstruction Type			Storm Grate/Utility Type	
		N/A			N/A
			Yes	Surface Condition? (G/P)	Good

Remove & Replace Entire Ramp.
