# Access Compliance Report

## Public Rights-of-Way

### (Curb Ramps)

Intersection ID: 15800	Main Street: PROVIDENCE_RD	Cross Street: QUEENS_RD	Location:	E
ADA ID: C3289588C5A5	Ramp Type: Perp	Initial Pass/Fail: Pass	Overall Compliance: Yes	Severity Score: 0

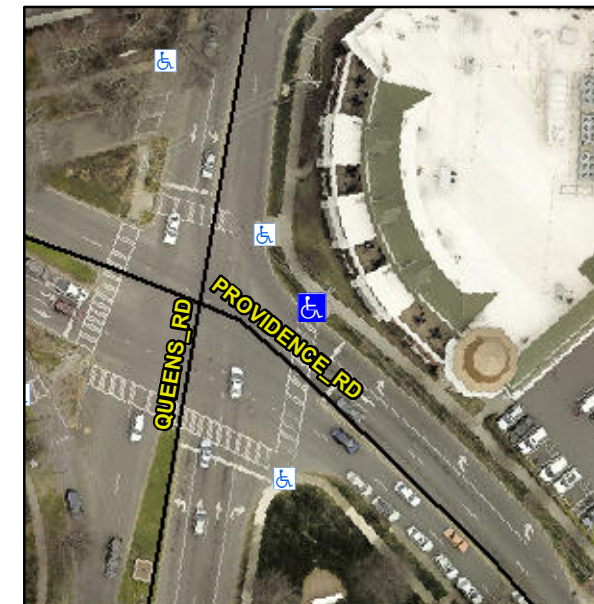
Compliance	Description	Data	Compliance	Description	Data
N/A	Ramp Length (in)	95.0	Yes	Ramp Slope (%)	7.2
Yes	Ramp Width (in)	49.0	Yes	Ramp XSlope (%)	1.1
N/A	Flare Type LT	Sloped	N/A	Flare Type RT	N/A
N/A	Flare Slope LT (%)	5.6	Yes	Flare Slope RT (%)	5.2
N/A	Flare Traversable LT?	Yes	N/A	Flare Traversable RT?	Yes
Yes	Landing Length (in)	72.0	Yes	DWS Provided?	Yes
Yes	Landing Width (in)	49.0	Yes	DWS Contrast?	Yes
Yes	Landing Slope (%)	1.8	Yes	DWS Length (in)	24.5
Yes	Landing X Slope (%)	1.8	Yes	DWS Full Width?	Yes
N/A	Landing Curb? (Y/N)	No	Yes	DWS Offset (in)	0.0
N/A	Shared Landing?	No			
Yes	Gutter Ponding?	No	Yes	Gutter Slope (%)	0.6
Yes	Gutter Lip Ht (in)	0.0	Yes	Gutter X Slope (%)	0.5
N/A	Painted X Walk1?	Yes	N/A	Painted X Walk2?	N/A
	X Walk 1 Direction	To SW		X Walk 2 Direction	N/A
N/A	X Walk 1 Width (in)	126.0	N/A	X Walk 2 Width (in)	N/A
	X Walk 1 Slope (%)	0.0		X Walk 2 Slope (%)	N/A
	X Walk 1 X Slope (%)	1.9		X Walk 2 X Slope (%)	N/A

Yes	Ramp inside XWalk1?	Yes	N/A	Ramp inside XWalk2?	N/A
	Road Slope (%)	N/A	N/A	Clear Space?	Yes
	Road X Slope (%)	N/A	N/A	Clear Space to XWalk (in)	N/A
Yes	Any Obstructions?	No	Yes	Storm Grate/Utility Hazard?	No
	Obstruction Type			Storm Grate/Utility Type	
		N/A			N/A
			Yes	Surface Condition? (G/P)	Good

Possible Solutions:

N/A
