Access Compliance Report

Public Rights-of-Way

(Curb Ramps)

Intersection ID: N/A	Main Street: S_WENDOVER_RD	Cross Street: FOREST_DR	Location: NW
ADA ID: C32A296B2DFC	Ramp Type: PerpDiag	Initial Pass/Fail: Fail	Overall Compliance: No
		Severity Score: 12.5

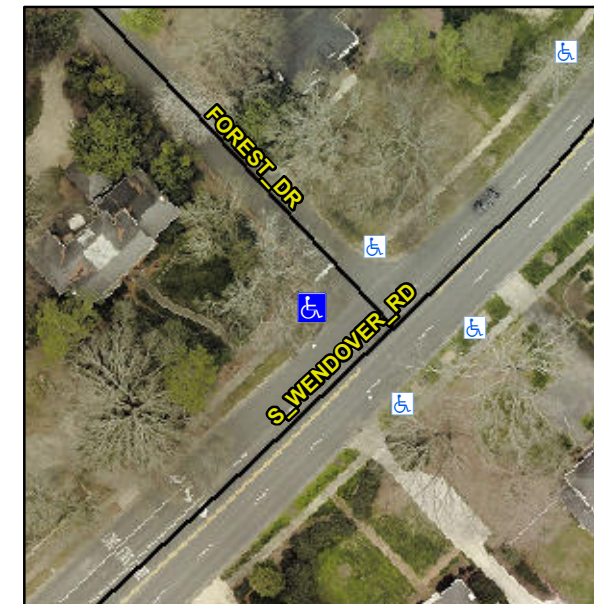
Not Found, R304.5.3

Compliance	Description	Data	Compliance	Description	Data
N/A	Ramp Length (in)	61.0	Yes	Ramp Slope (%)	6.4
Yes	Ramp Width (in)	48.0	No	Ramp XSlope (%)	5.5
N/A	Flare Type LT	N/A	N/A	Flare Type RT	N/A
N/A	Flare Slope LT (%)	N/A	N/A	Flare Slope RT (%)	N/A
N/A	Flare Traversable LT?	N/A	N/A	Flare Traversable RT?	N/A
N/A	Landing Length (in)	N/A	N/A	DWS Provided?	N/A
N/A	Landing Width (in)	N/A	N/A	DWS Contrast?	N/A
N/A	Landing Slope (%)	N/A	N/A	DWS Length (in)	N/A
N/A	Landing X Slope (%)	N/A	N/A	DWS Full Width?	N/A
N/A	Landing Curb? (Y/N)	N/A	N/A	DWS Offset (in)	N/A
N/A	Shared Landing?	N/A			
N/A	Gutter Ponding?	N/A	N/A	Gutter Slope (%)	N/A
N/A	Gutter Lip Ht (in)	N/A	N/A	Gutter X Slope (%)	N/A
N/A	Painted X Walk1?	No	N/A	Painted X Walk2?	No
	X Walk 1 Direction	To S		X Walk 2 Direction	To E
N/A	X Walk 1 Width (in)	N/A	N/A	X Walk 2 Width (in)	N/A
	X Walk 1 Slope (%)	4.6		X Walk 2 Slope (%)	1.6
	X Walk 1 X Slope (%)	1.3		X Walk 2 X Slope (%)	2.1

N/A	Ramp inside XWalk1?	N/A	N/A	Ramp inside XWalk2?	N/A
	Road Slope (%)	3.0	N/A	Clear Space?	N/A
	Road X Slope (%)	1.8	N/A	Clear Space to XWalk (in)	N/A
N/A	Any Obstructions?	N/A	N/A	Storm Grate/Utility Hazard?	N/A
	Obstruction Type			Storm Grate/Utility Type	
		N/A			N/A
			Yes	Surface Condition? (G/P)	Good

Remove & Replace Curb Ramp With Two New Directional Ramps or Equivalent.

Total Cost: \$ 3200.00
