# Access Compliance Report

## Public Rights-of-Way

### (Curb Ramps)

| Intersection ID: 54229 | Main Street: OAKHAVEN_GLEN_LN | Cross Street: PROVIDENCE_RD_WEST | Location: NW |

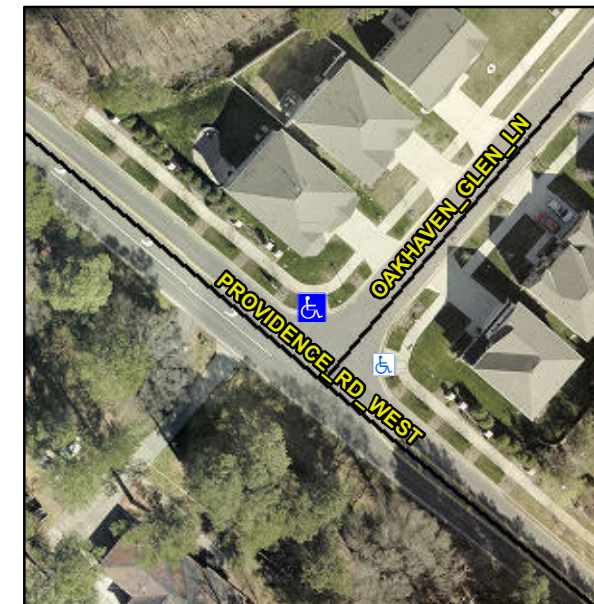
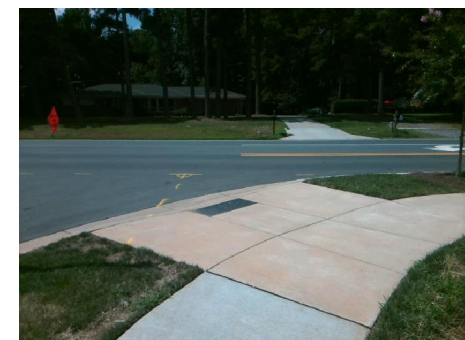
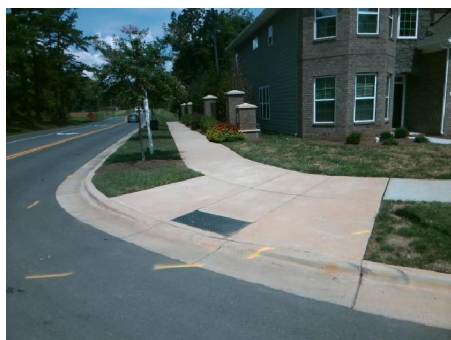
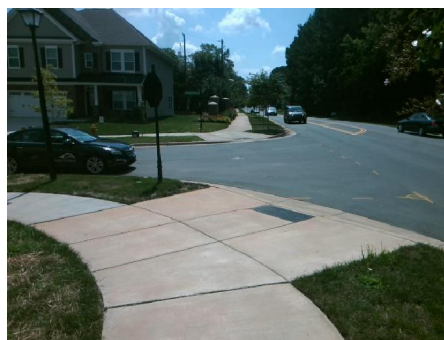
| ADA ID: C32A29B8F813 | Ramp Type: BlendTrans2 | Initial Pass/Fail: Fail | Overall Compliance: No |
| Severity Score: 10 | | | |

**R304.5.1, R304.5.3**

| Compliance | Description | Data | Compliance | Description | Data |
|---|---|---|---|---|---|
| N/A | Ramp Length (in) | 164.0 | Yes | BlendTrans Slope (%) | 4.1 |
| No | Ramp Width (in) | 43.0 | No | BlendTrans XSlope (%) | 3.0 |

**Remove & Replace Curb Ramp With Two New Directional Ramps or Equivalent.**

Total Cost: \$ 3200.00
