Access Compliance Report Public Rights-of-Way (Curb Ramps)

Cross Street: PARK RD Intersection ID: 15422 Main Street: CHARLOTTE DR Location: NE Initial Pass/Fail: Fail **Overall Compliance: No Severity Score:** ADA ID: C33212EA5439 Ramp Type: PerpDiag 12.5

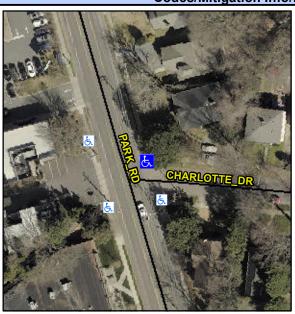
Total Cost: 3200.00 Compliance Description Data Compliance Description Data No N/A Ramp Length (in) 60.0 Ramp Slope (%) 9.0 Yes Ramp Width (in) 76.0 Yes Ramp XSlope (%) 0.5 N/A N/A Flare Type LT N/A Flare Type RT N/A N/A N/A N/A Flare Slope RT (%) N/A Flare Slope LT (%) N/A Flare Traversable LT? N/A N/A Flare Traversable RT? N/A N/A N/A N/A **DWS Provided?** N/A Landing Length (in) N/A Landing Width (in) N/A N/A **DWS Contrast?** N/A N/A N/A N/A Landing Slope (%) DWS Length (in) N/A N/A Landing X Slope (%) N/A N/A DWS Full Width? N/A N/A Landing Curb? (Y/N) N/A N/A DWS Offset (in) N/A N/A N/A Shared Landing? N/A **Gutter Ponding?** N/A N/A Gutter Slope (%) N/A N/A Gutter Lip Ht (in) N/A N/A Gutter X Slope (%) N/A N/A Painted X Walk1? No N/A Painted X Walk2? No X Walk 1 Direction To NW X Walk 2 Direction To S N/A N/A X Walk 1 Width (in) X Walk 2 Width (in) N/A X Walk 1 Slope (%) 4.7 X Walk 2 Slope (%) 1.9 X Walk 1 X Slope (%) 0.6 X Walk 2 X Slope (%) 3.2 N/A N/A N/A Ramp inside XWalk2? N/A Ramp inside XWalk1? Road Slope (%) 2.5 N/A Clear Space? N/A N/A Road X Slope (%) 2.0 Clear Space to XWalk (in) N/A N/A N/A N/A Any Obstructions? Storm Grate/Utility Hazard? N/A **Obstruction Type** Storm Grate/Utility Type

Remove & Replace Curb Ramp With Two New Directional Ramps or Equivalent. Surveyor Notes: N/A PROW/ADA: Not Found, R304.2.2
