# Access Compliance Report

## Public Rights-of-Way

### (Curb Ramps)

Intersection ID: 25357	Main Street: RAINTREE_LN	Cross Street: WILLOW_POINT_DR	Location: NE
ADA ID: C3332FBC84D1	Ramp Type: Perp	Initial Pass/Fail: Fail	Overall Compliance: No
Codes/Mitigation Info/Possible Solution		Field Measurements/Component Compliance

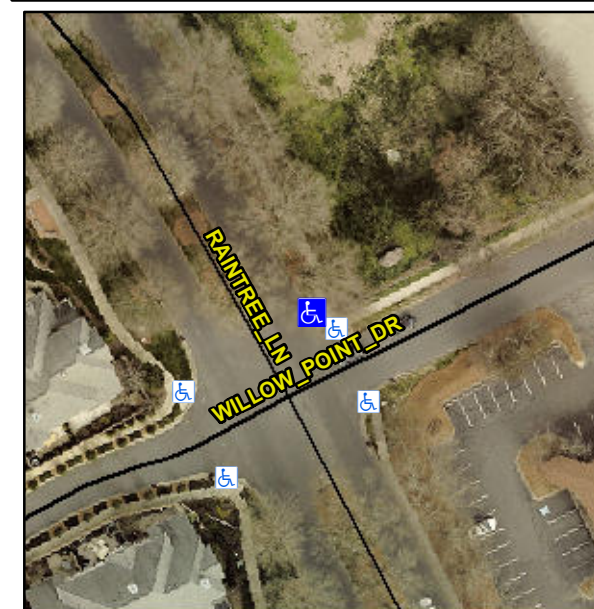
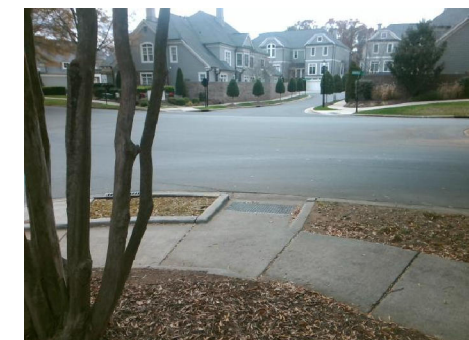
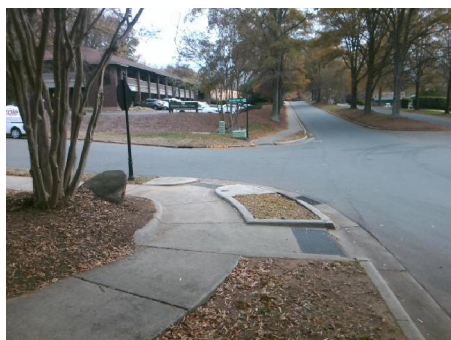
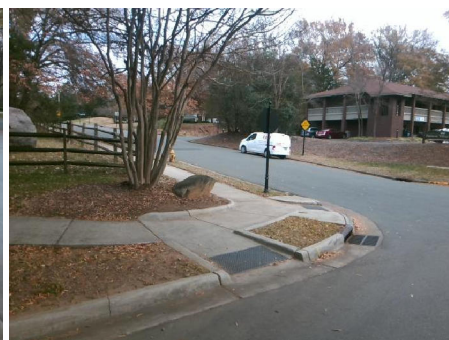
**Not Found, R304.2.2, R304.5.3**

Compliance	Description	Data	Compliance	Description	Data
N/A	Ramp Length (in)	54.0	No	Ramp Slope (%)	8.4
Yes	Ramp Width (in)	52.5	No	Ramp XSlope (%)	2.6
N/A	Flare Type LT	N/A	N/A	Flare Type RT	N/A
N/A	Flare Slope LT (%)	N/A	N/A	Flare Slope RT (%)	N/A
N/A	Flare Traversable LT?	N/A	N/A	Flare Traversable RT?	N/A
N/A	Landing Length (in)	N/A	N/A	DWS Provided?	N/A
N/A	Landing Width (in)	N/A	N/A	DWS Contrast?	N/A
N/A	Landing Slope (%)	N/A	N/A	DWS Length (in)	N/A
N/A	Landing X Slope (%)	N/A	N/A	DWS Full Width?	N/A
N/A	Landing Curb? (Y/N)	N/A	N/A	DWS Offset (in)	N/A
N/A	Shared Landing?	N/A			
N/A	Gutter Ponding?	N/A	N/A	Gutter Slope (%)	N/A
N/A	Gutter Lip Ht (in)	N/A	N/A	Gutter X Slope (%)	N/A
N/A	Painted X Walk1?	No	N/A	Painted X Walk2?	N/A
	X Walk 1 Direction	To SW		X Walk 2 Direction	N/A
N/A	X Walk 1 Width (in)	N/A	N/A	X Walk 2 Width (in)	N/A
	X Walk 1 Slope (%)	4.3		X Walk 2 Slope (%)	N/A
	X Walk 1 X Slope (%)	2.4		X Walk 2 X Slope (%)	N/A

N/A	Ramp inside XWalk1?	N/A	N/A	Ramp inside XWalk2?	N/A
	Road Slope (%)	N/A	N/A	Clear Space?	N/A
	Road X Slope (%)	N/A	N/A	Clear Space to XWalk (in)	N/A
N/A	Any Obstructions?	N/A	N/A	Storm Grate/Utility Hazard?	N/A
	Obstruction Type			Storm Grate/Utility Type	
		N/A			N/A
			Yes	Surface Condition? (G/P)	Good

**Remove & Replace Entire Ramp.**

Total Cost: \$ 1850.00
