# Access Compliance Report

## Public Rights-of-Way (Curb Ramps)

Intersection ID: 25199	Main Street: DONNEGAL_FARM_RD	Cross Street: BRIDLE_BROOK_WY	Location: SW
ADA ID: C33475796319	Ramp Type: Perp	Initial Pass/Fail: Fail	Overall Compliance: No
Severity Score: 37.5			
Codes/Mitigation Info/Possible Solution		Field Measurements/Component Compliance

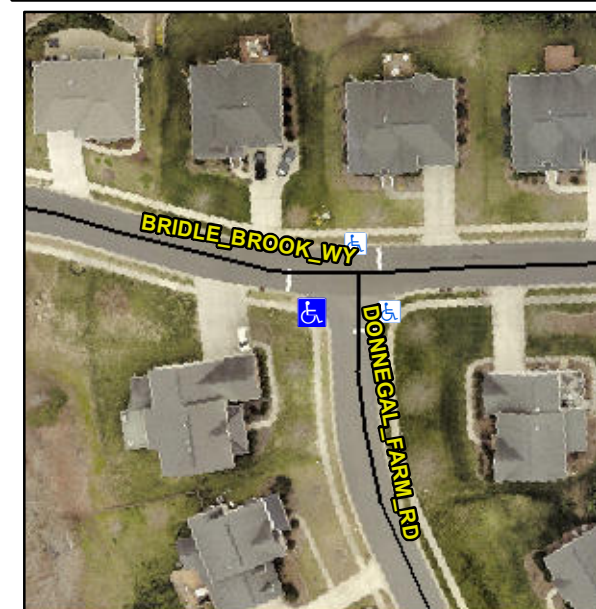
**Not Found, R304.2.2, R304.5.3**

Compliance	Description	Data	Compliance	Description	Data
N/A	Ramp Length (in)	48.0	No	Ramp Slope (%)	10.3
Yes	Ramp Width (in)	48.0	No	Ramp XSlope (%)	8.3
N/A	Flare Type LT	N/A	N/A	Flare Type RT	N/A
N/A	Flare Slope LT (%)	N/A	N/A	Flare Slope RT (%)	N/A
N/A	Flare Traversable LT?	N/A	N/A	Flare Traversable RT?	N/A
N/A	Landing Length (in)	N/A	N/A	DWS Provided?	N/A
N/A	Landing Width (in)	N/A	N/A	DWS Contrast?	N/A
N/A	Landing Slope (%)	N/A	N/A	DWS Length (in)	N/A
N/A	Landing X Slope (%)	N/A	N/A	DWS Full Width?	N/A
N/A	Landing Curb? (Y/N)	N/A	N/A	DWS Offset (in)	N/A
N/A	Shared Landing?	N/A			
N/A	Gutter Ponding?	N/A	N/A	Gutter Slope (%)	N/A
N/A	Gutter Lip Ht (in)	N/A	N/A	Gutter X Slope (%)	N/A
N/A	Painted X Walk1?	No	N/A	Painted X Walk2?	N/A
	X Walk 1 Direction	To E		X Walk 2 Direction	N/A
N/A	X Walk 1 Width (in)	N/A	N/A	X Walk 2 Width (in)	N/A
	X Walk 1 Slope (%)	6.2		X Walk 2 Slope (%)	N/A
	X Walk 1 X Slope (%)	3.5		X Walk 2 X Slope (%)	N/A

**Remove & Replace Entire Ramp.**

Total Cost: \$ 1850.00

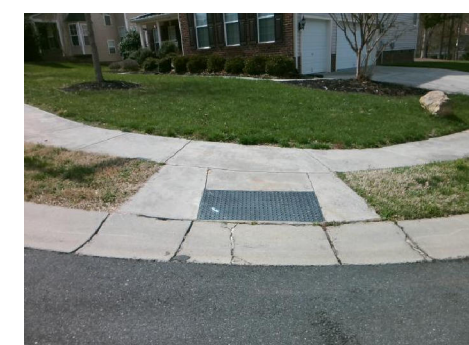
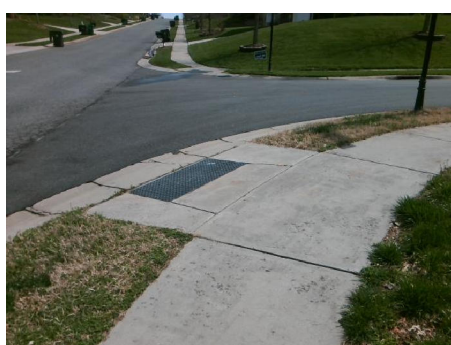
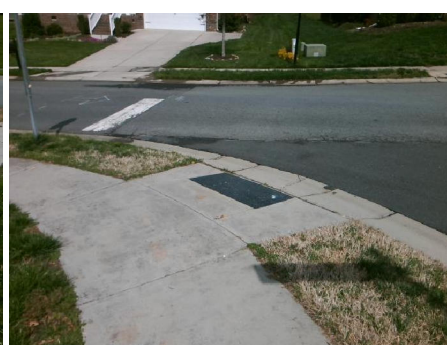
N/A	Ramp inside XWalk1?	N/A	N/A	Ramp inside XWalk2?	N/A
	Road Slope (%)	N/A	N/A	Clear Space?	N/A
	Road X Slope (%)	N/A	N/A	Clear Space to XWalk (in)	N/A
N/A	Any Obstructions?	N/A	N/A	Storm Grate/Utility Hazard?	N/A
	Obstruction Type			Storm Grate/Utility Type	
		N/A			N/A
			Yes	Surface Condition? (G/P)	Good
