# Access Compliance Report

## Public Rights-of-Way

### (Curb Ramps)

Intersection ID: 26714	Main Street: NANCY_CREEK_RD	Cross Street: OPEN_BOOK_LN	Location: NE
ADA ID: C33482193F9A	Ramp Type: BlendTrans1	Initial Pass/Fail: Fail	Overall Compliance: No
Severity Score: 12.5			
Codes/Mitigation Info/Possible Solution		Field Measurements/Component Compliance

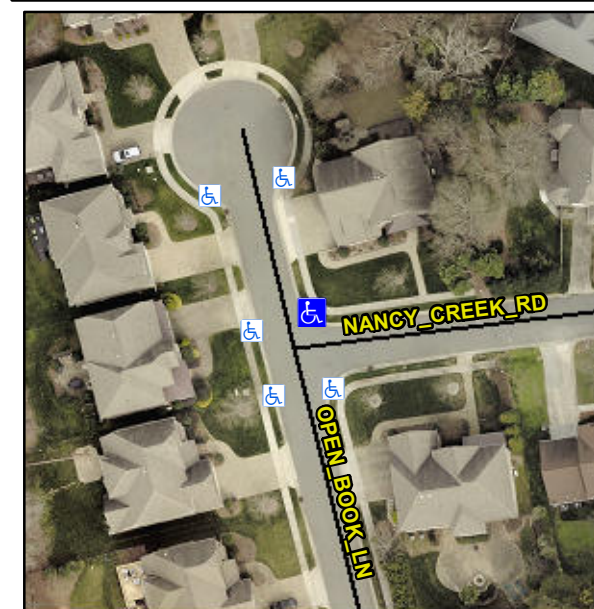
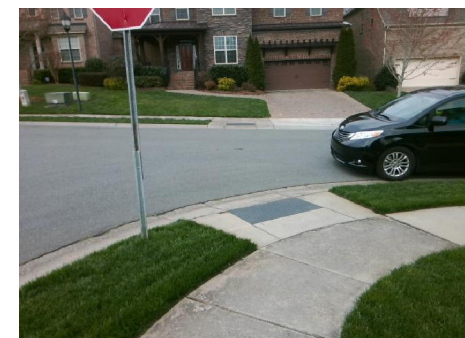
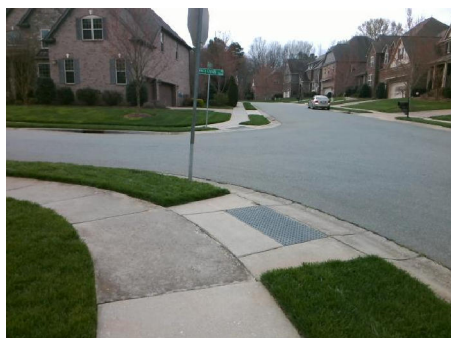
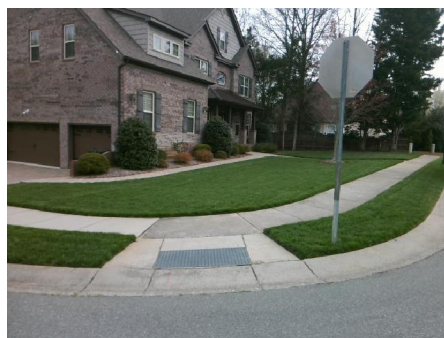
**Not Found, R304.5.3**

Compliance	Description	Data	Compliance	Description	Data
N/A	Ramp Length (in)	48.0	Yes	BlendTrans Slope (%)	2.8
Yes	Ramp Width (in)	48.0	No	BlendTrans XSlope (%)	5.3
N/A	Flare Type LT	N/A	N/A	Flare Type RT	N/A
N/A	Flare Slope LT (%)	N/A	N/A	Flare Slope RT (%)	N/A
N/A	Flare Traversable LT?	N/A	N/A	Flare Traversable RT?	N/A
N/A	Landing Length (in)	N/A	N/A	DWS Provided?	N/A
N/A	Landing Width (in)	N/A	N/A	DWS Contrast?	N/A
N/A	Landing Slope (%)	N/A	N/A	DWS Length (in)	N/A
N/A	Landing X Slope (%)	N/A	N/A	DWS Full Width?	N/A
N/A	Landing Curb? (Y/N)	N/A	N/A	DWS Offset (in)	N/A
N/A	Shared Landing?	N/A			
N/A	Gutter Ponding?	N/A	N/A	Gutter Slope (%)	N/A
N/A	Gutter Lip Ht (in)	N/A	N/A	Gutter X Slope (%)	N/A
N/A	Painted X Walk1?	No	N/A	Painted X Walk2?	No
	X Walk 1 Direction	To W		X Walk 2 Direction	To S
	X Walk 1 Width (in)	N/A		X Walk 2 Width (in)	N/A
	X Walk 1 Slope (%)	2.6		X Walk 2 Slope (%)	5.5
	X Walk 1 X Slope (%)	5.6		X Walk 2 X Slope (%)	1.8

N/A	Ramp inside XWalk1?	N/A	N/A	Ramp inside XWalk2?	N/A
	Road Slope (%)	4.3		Clear Space?	N/A
	Road X Slope (%)	5.5	N/A	Clear Space to XWalk (in)	N/A
N/A	Any Obstructions?	N/A	N/A	Storm Grate/Utility Hazard?	N/A
	Obstruction Type			Storm Grate/Utility Type	
		N/A			N/A
			Yes	Surface Condition? (G/P)	Good
			No	Curb Slope (%)	15.2

**Remove & Replace Curb Ramp With Two New Directional Ramps or Equivalent.**

Total Cost: \$ 3200.00
