# Access Compliance Report

## Public Rights-of-Way

### (Curb Ramps)

Intersection ID: 13947	Main Street: CHERRY_ST	Cross Street: CHARLOTTETOWNE_AV	Location: S
ADA ID: C3404B1B48CD	Ramp Type: Perp	Initial Pass/Fail: Fail	Overall Compliance: No
Severity Score: 26.25			
Codes/Mitigation Info/Possible Solution		Field Measurements/Component Compliance

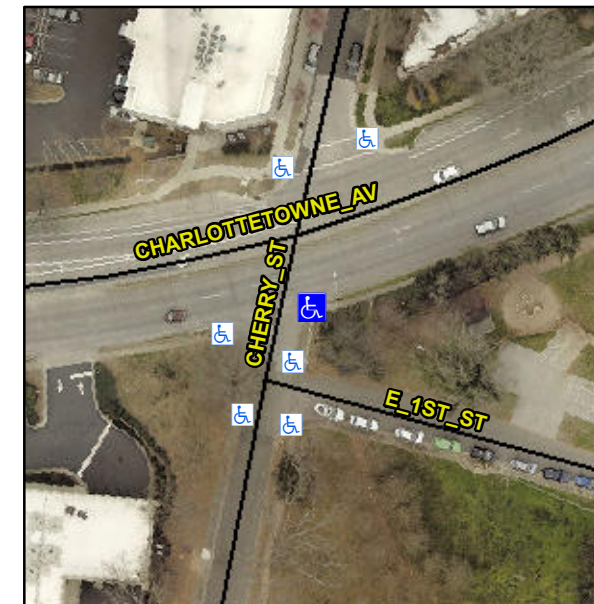
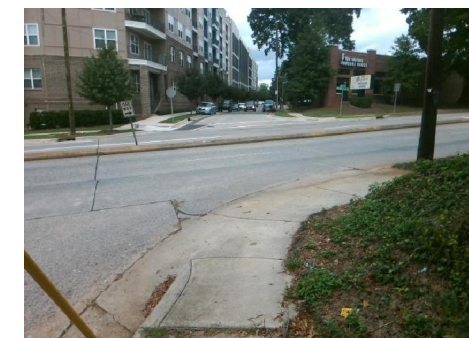
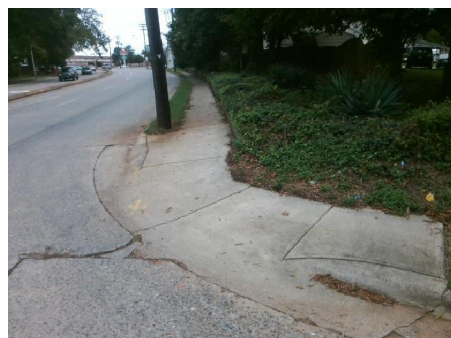
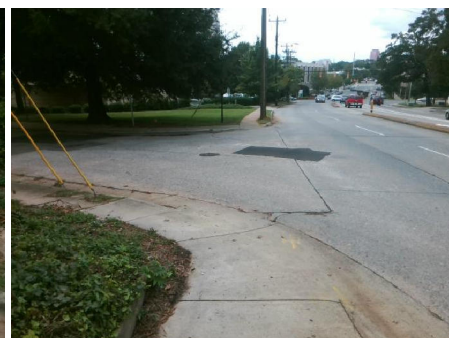
**Not Found, R304.2.2, R304.5.3**

Compliance	Description	Data	Compliance	Description	Data
N/A	Ramp Length (in)	48.0	No	Ramp Slope (%)	13.5
Yes	Ramp Width (in)	109.0	No	Ramp XSlope (%)	4.2
N/A	Flare Type LT	N/A	N/A	Flare Type RT	N/A
N/A	Flare Slope LT (%)	N/A	N/A	Flare Slope RT (%)	N/A
N/A	Flare Traversable LT?	N/A	N/A	Flare Traversable RT?	N/A
N/A	Landing Length (in)	N/A	N/A	DWS Provided?	N/A
N/A	Landing Width (in)	N/A	N/A	DWS Contrast?	N/A
N/A	Landing Slope (%)	N/A	N/A	DWS Length (in)	N/A
N/A	Landing X Slope (%)	N/A	N/A	DWS Full Width?	N/A
N/A	Landing Curb? (Y/N)	N/A	N/A	DWS Offset (in)	N/A
N/A	Shared Landing?	N/A			
N/A	Gutter Ponding?	N/A	N/A	Gutter Slope (%)	N/A
N/A	Gutter Lip Ht (in)	N/A	N/A	Gutter X Slope (%)	N/A
N/A	Painted X Walk1?	No	N/A	Painted X Walk2?	N/A
	X Walk 1 Direction	To SW		X Walk 2 Direction	N/A
N/A	X Walk 1 Width (in)	N/A	N/A	X Walk 2 Width (in)	N/A
	X Walk 1 Slope (%)	3.4		X Walk 2 Slope (%)	N/A
	X Walk 1 X Slope (%)	3.9		X Walk 2 X Slope (%)	N/A

N/A	Ramp inside XWalk1?	N/A	N/A	Ramp inside XWalk2?	N/A
	Road Slope (%)	N/A	N/A	Clear Space?	N/A
	Road X Slope (%)	N/A	N/A	Clear Space to XWalk (in)	N/A
N/A	Any Obstructions?	N/A	N/A	Storm Grate/Utility Hazard?	N/A
	Obstruction Type			Storm Grate/Utility Type	
		N/A			N/A
		Yes		Surface Condition? (G/P)	Good

**Remove & Replace Entire Ramp.**

Total Cost: \$ 1850.00
