# Access Compliance Report

## Public Rights-of-Way

### (Curb Ramps)

Intersection ID: 12242	Main Street: S_CEDAR_ST	Cross Street: MORRIS_ST	Location: SE
ADA ID: C367BC538117	Ramp Type: Directional	Initial Pass/Fail: Fail	Overall Compliance: No
Severity Score: 12.5			
Codes/Mitigation Info/Possible Solution		Field Measurements/Component Compliance

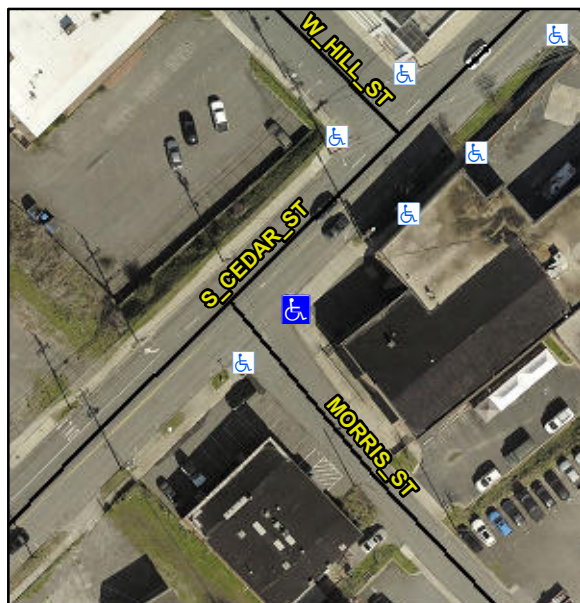
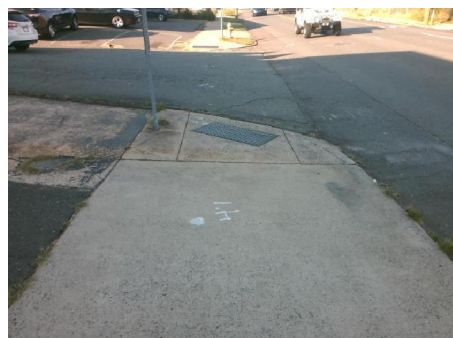
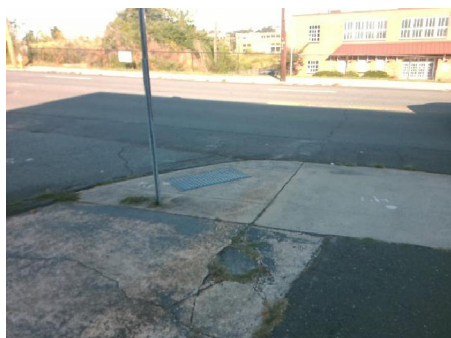
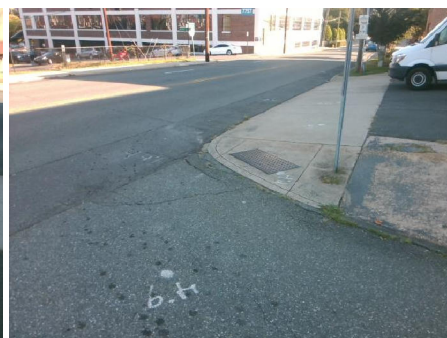
**R304.5.3**

Compliance	Description	Data	Compliance	Description	Data
N/A	Ramp Length (in)	48.0	N/A	Grade Break?	N/A
Yes	Ramp Width (in)	60.0	N/A	Grade Break Slope (%)	0.0
Yes	Ramp Slope (%)	0.8	N/A	Grade Break XSlope (%)	0.0
No	Ramp XSlope (%)	6.9			
N/A	Flare Type LT	N/A	N/A	Flare Type RT	N/A
N/A	Flare Slope LT (%)	N/A	N/A	Flare Slope RT (%)	0.0
N/A	Flare Traversable LT?	N/A	N/A	Flare Traversable RT?	N/A
N/A	Landing Length (in)	0.0	N/A	DWS Provided?	N/A
N/A	Landing Width (in)	0.0	N/A	DWS Contrast?	N/A
N/A	Landing Slope (%)	0.0	N/A	DWS Length (in)	N/A
N/A	Landing X Slope (%)	0.0	N/A	DWS Full Width?	N/A
N/A	Landing Curb? (Y/N)	N/A	N/A	DWS Offset LT (in)	N/A
N/A	Shared Landing?	N/A	N/A	DWS Offset RT (in)	N/A
N/A	Gutter Ponding?	0.0	N/A	Gutter Slope (%)	N/A
N/A	Gutter Lip Ht (in)	0.0	N/A	Gutter X Slope (%)	N/A
N/A	Painted X Walk1?	No		Road Slope (%)	5.3
	X Walk 1 Direction	To SW		Road X Slope (%)	5.6
	X Walk 1 Width (in)	N/A		Clear Space?	N/A

X Walk 1 Slope (%)	5.3	N/A	Clear Space to XWalk (in)	N/A
	X Walk 1 X Slope (%)	5.6	N/A	Storm Grate/Utility Hazard?	N/A
N/A	Ramp inside XWalk1?	N/A		Storm Grate/Utility Type	
N/A	Any Obstructions?	N/A			N/A
	Obstruction Type		Yes	Surface Condition? (G/P)	Good
			N/A	Curb Slope (%)	1.5

**Remove & Replace Entire Ramp.**
