# Access Compliance Report

## Public Rights-of-Way

| Intersection ID: 43480 | Main Street: LIONESS_ST | Cross Street: ERWIN_RD | Location: SE |
| ADA ID: C36986BCA9C6 | Ramp Type: PerpDiag | Initial Pass/Fail: Pass | Overall Compliance: No |

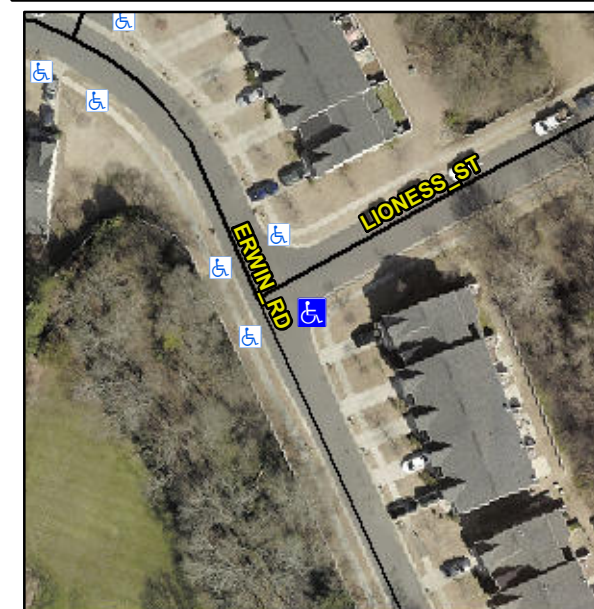
**Not Found, R304.2.1, R304.2.2-Perp, R304.3.2-Para, R304.5.4**

| Compliance | Description | Data | Compliance | Description | Data |
|---|---|---|---|---|---|
| No | Landing Length (in) | 47.0 | Yes | DWS Provided? | Yes |
| No | Landing Slope (%) | 3.1 | Yes | DWS Length (in) | 24.0 |
| Yes | Gutter Ponding? | No | No | Gutter Slope (%) | 11.8 |

**Remove & Replace Curb Ramp With Two New Directional Ramps or Equivalent. Remove & Replace Gutter.**

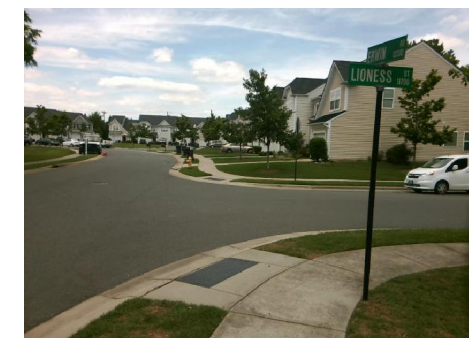
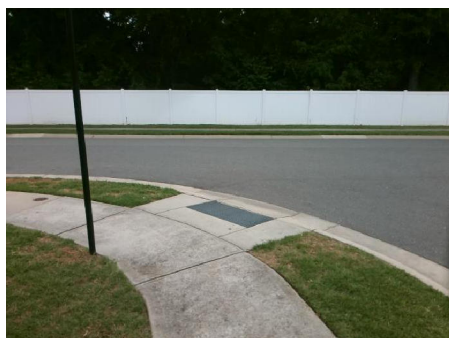
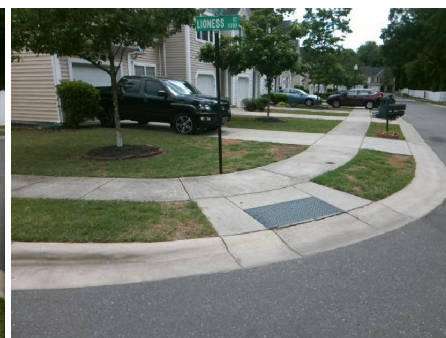
Street 1 Name LIONESS ST  
 Stop Condition-Street 2 StopSign  
 Street 2 Name ERWIN RD  
 Stop Condition-Street 1 None
