Access Compliance Report Public Rights-of-Way (Curb Ramps)

Intersection ID: 11747Main Street: W_10TH_STCross Street: N_TRYON_STLocation: WADA ID: C36D3328EA5FRamp Type: PerpDiagInitial Pass/Fail: Fail Overall Compliance: No Severity Score: 10

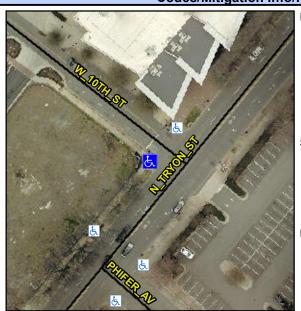
Fleid Measurements/Component Compliance							
	Comp	Compliance Description		Compliance Description		Description	Data
	N/A	Ramp Length (in)	67.0	Yes	Ramp	Slope (%)	5.6
	No	Ramp Width (in)	38.0	No	Ramp	XSlope (%)	4.2
	N/A	Flare Type LT	N/A	N/A	Flare	Type RT	N/A
	N/A	Flare Slope LT (%)	N/A	N/A	Flare	Slope RT (%)	N/A
	N/A	Flare Traversable LT?	N/A	N/A	Flare	Traversable RT?	N/A
	N/A	Landing Length (in)	N/A	N/A	DWS	Provided?	N/A
	N/A	Landing Width (in)	N/A	N/A	DWS	Contrast?	N/A
	N/A	Landing Slope (%)	N/A	N/A	DWS	Length (in)	N/A
	N/A	Landing X Slope (%)	N/A	N/A	DWS	Full Width?	N/A
	N/A	Landing Curb? (Y/N)	N/A	N/A	DWS	Offset (in)	N/A
	N/A	Shared Landing?	N/A				
	N/A	Gutter Ponding?	N/A	N/A	Gutte	er Slope (%)	N/A
	N/A	Gutter Lip Ht (in)	N/A	N/A	Gutte	er X Slope (%)	N/A
	N/A	Painted X Walk1?	No	N/A	Paint	ed X Walk2?	No
		X Walk 1 Direction	To SE		X Wa	lk 2 Direction	To NE
	N/A	X Walk 1 Width (in)	N/A	N/A	X Wa	lk 2 Width (in)	N/A

X Walk 1 Slope (%)	0.5		X Wa	lk 2 Slope (%)	1.3
		X Walk 1 X Slope (%)	3.4		X Wa	lk 2 X Slope (%)	0.4
	N/A	Ramp inside XWalk1?	N/A	N/A	Ram	inside XWalk2?	N/A
		Road Slope (%)	0.3	N/A	Clear	Space?	N/A
		Road X Slope (%)	5.1	N/A	Clear	Space to XWalk (in)	N/A
	N/A	Any Obstructions?	N/A	N/A	Storn	n Grate/Utility Hazard?	N/A
				1	_

Remove & Replace Curb Ramp With Two New Directional Ramps or Equivalent.

R304.5.1, R304.5.3
