Access Compliance Report

Public Rights-of-Way

Intersection ID: 30255	Main Street: OLD_IRONSIDE_DR	Cross Street: WYLAM_DILLY_CT	Location: E
ADA ID: C3797ACD77DC	Ramp Type: PerpDiag	Initial Pass/Fail: Pass	Overall Compliance: No
Severity Score: 15			
Codes/Mitigation Info/Possible Solution		Field Measurements/Component Compliance

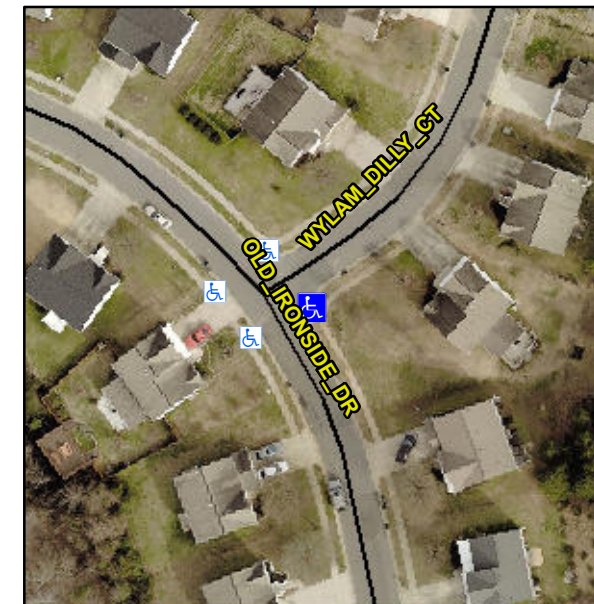
Compliance	Description	Data	Compliance	Description	Data
N/A	Ramp Length (in)	48.0	Yes	Ramp Slope (%)	7.1
Yes	Ramp Width (in)	48.5	Yes	Ramp XSlope (%)	0.3
N/A	Flare Type LT	Sloped	N/A	Flare Type RT	N/A
N/A	Flare Slope LT (%)	5.4	N/A	Flare Slope RT (%)	8.1
N/A	Flare Traversable LT?	No	N/A	Flare Traversable RT?	No
Yes	Landing Length (in)	48.0	No	DWS Provided?	No
No	Landing Width (in)	42.0	N/A	DWS Contrast?	No
No	Landing Slope (%)	5.1	N/A	DWS Length (in)	N/A
Yes	Landing X Slope (%)	1.3	N/A	DWS Full Width?	No
N/A	Landing Curb? (Y/N)	No	N/A	DWS Offset (in)	N/A
N/A	Shared Landing?	No			
Yes	Gutter Ponding?	No	No	Gutter Slope (%)	13.0
Yes	Gutter Lip Ht (in)	0.0	Yes	Gutter X Slope (%)	0.1
N/A	Painted X Walk1?	No	N/A	Painted X Walk2?	No
	X Walk 1 Direction	To NW		X Walk 2 Direction	To SW
N/A	X Walk 1 Width (in)	N/A	N/A	X Walk 2 Width (in)	N/A
	X Walk 1 Slope (%)	2.1		X Walk 2 Slope (%)	0.2
	X Walk 1 X Slope (%)	3.0		X Walk 2 X Slope (%)	0.5

N/A	Ramp inside XWalk1?	N/A	N/A	Ramp inside XWalk2?	N/A
	Road Slope (%)	0.6	N/A	Clear Space?	Yes
	Road X Slope (%)	1.3	N/A	Clear Space to XWalk (in)	N/A
Yes	Any Obstructions?	No	Yes	Storm Grate/Utility Hazard?	No
	Obstruction Type			Storm Grate/Utility Type	
		N/A			N/A
			Yes	Surface Condition? (G/P)	Good

Remove & Replace Curb Ramp With Two New Directional Ramps or Equivalent. Remove & Replace Gutter.

R304.2.1, R304.2.2-Perp, R304.3.2-Para, R305, R304.5.4
