# Access Compliance Report

## Public Rights-of-Way

| Intersection ID: 48503 | Main Street: KELBURN_LN | Cross Street: CASTLECOVE_RD | Location: NW |
| ADA ID: C37B6E151383 | Ramp Type: PerpDiag | Initial Pass/Fail: Fail | Overall Compliance: No |

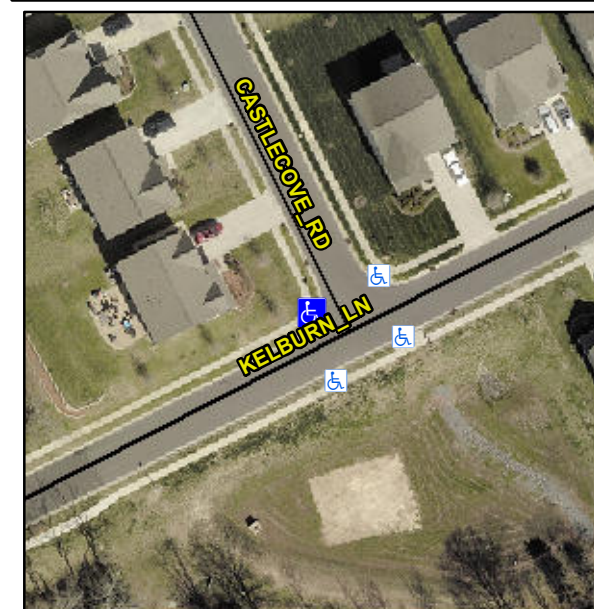
| Severity Score: 13.75 | | | |

**R304.2.2, R304.5.3**

| Compliance | Description | Data | Compliance | Description | Data |
|---|---|---|---|---|---|
| N/A | Ramp Length (in) | 46.5 | No | Ramp Slope (%) | 9.4 |
| Yes | Ramp Width (in) | 48.0 | No | Ramp XSlope (%) | 2.8 |

**Remove & Replace Curb Ramp With Two New Directional Ramps or Equivalent.**
