Access Compliance Report

Public Rights-of-Way

(Curb Ramps)

Intersection ID: 42550	Main Street: ENEIDA_SUE_DR	Cross Street: JOANNAS_CT	Location: E
ADA ID: C389B770AD8B	Ramp Type: PerpDiag	Initial Pass/Fail: Fail	Overall Compliance: No
Severity Score: 22.5			
Codes/Mitigation Info/Possible Solution		Field Measurements/Component Compliance

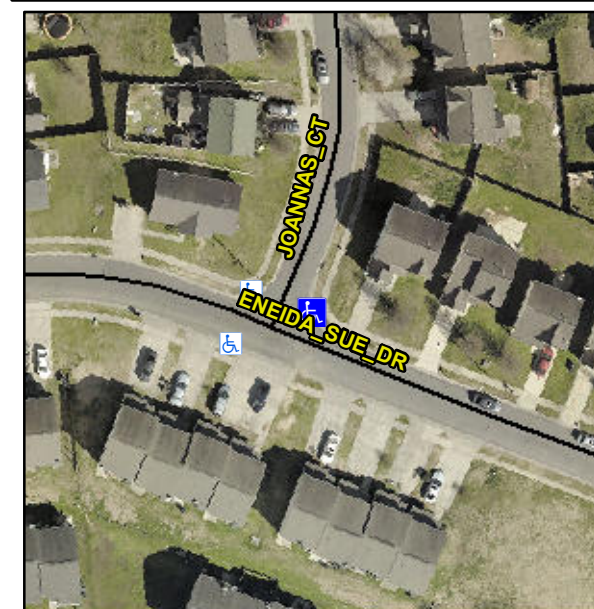
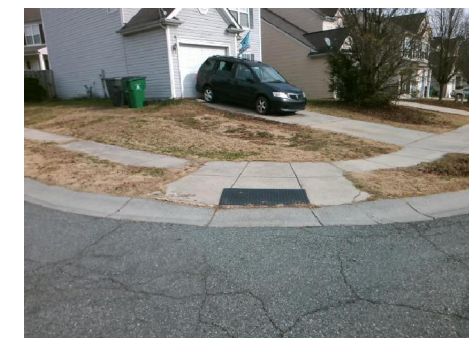
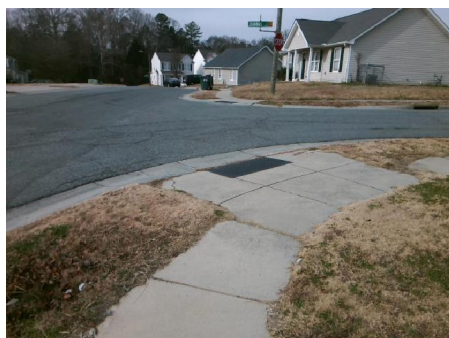
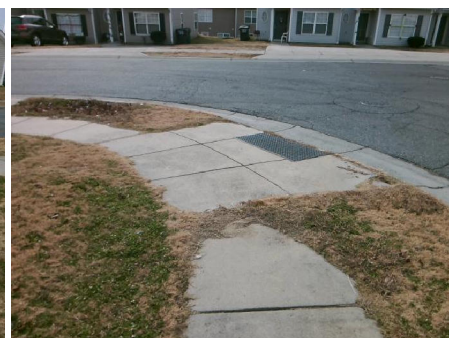
Not Found, R304.5.1, R304.2.2, R304.5.3

Compliance	Description	Data	Compliance	Description	Data
N/A	Ramp Length (in)	51.0	No	Ramp Slope (%)	9.2
No	Ramp Width (in)	38.5	No	Ramp XSlope (%)	4.2
N/A	Flare Type LT	N/A	N/A	Flare Type RT	N/A
N/A	Flare Slope LT (%)	N/A	N/A	Flare Slope RT (%)	N/A
N/A	Flare Traversable LT?	N/A	N/A	Flare Traversable RT?	N/A
N/A	Landing Length (in)	N/A	N/A	DWS Provided?	N/A
N/A	Landing Width (in)	N/A	N/A	DWS Contrast?	N/A
N/A	Landing Slope (%)	N/A	N/A	DWS Length (in)	N/A
N/A	Landing X Slope (%)	N/A	N/A	DWS Full Width?	N/A
N/A	Landing Curb? (Y/N)	N/A	N/A	DWS Offset (in)	N/A
N/A	Shared Landing?	N/A			
N/A	Gutter Ponding?	N/A	N/A	Gutter Slope (%)	N/A
N/A	Gutter Lip Ht (in)	N/A	N/A	Gutter X Slope (%)	N/A
N/A	Painted X Walk1?	No	N/A	Painted X Walk2?	No
	X Walk 1 Direction	To NW		X Walk 2 Direction	To SW
N/A	X Walk 1 Width (in)	N/A	N/A	X Walk 2 Width (in)	N/A
	X Walk 1 Slope (%)	4.3		X Walk 2 Slope (%)	1.1
	X Walk 1 X Slope (%)	2.9		X Walk 2 X Slope (%)	3.1

N/A	Ramp inside XWalk1?	N/A	N/A	Ramp inside XWalk2?	N/A
	Road Slope (%)	5.1	N/A	Clear Space?	N/A
	Road X Slope (%)	3.0	N/A	Clear Space to XWalk (in)	N/A
N/A	Any Obstructions?	N/A	N/A	Storm Grate/Utility Hazard?	N/A
	Obstruction Type			Storm Grate/Utility Type	
		N/A			N/A
			Yes	Surface Condition? (G/P)	Good

Remove & Replace Curb Ramp With Two New Directional Ramps or Equivalent.
