Access Compliance Report

Public Rights-of-Way

(Curb Ramps)

Intersection ID: 9002	Main Street: BARRINGTON_DR	Cross Street: COVECREEK_DR	Location: SW
ADA ID: C38CD4F2FF21	Ramp Type: Perp	Initial Pass/Fail: Fail	Overall Compliance: No
		Severity Score: 12.5

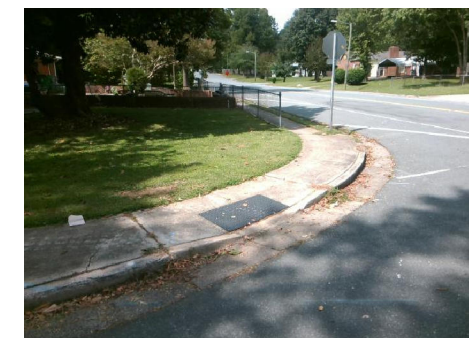
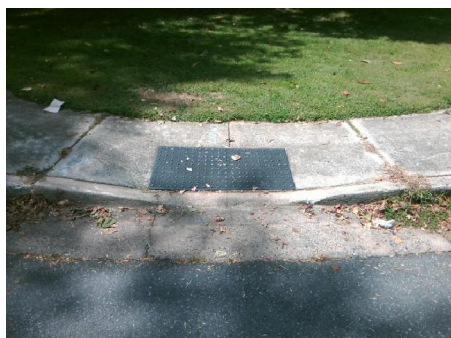
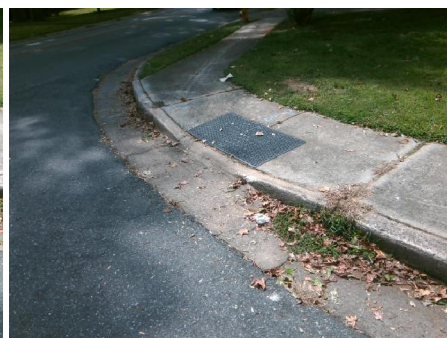
Compliance	Description	Data	Compliance	Description	Data
N/A	Ramp Length (in)	48.0	No	Ramp Slope (%)	10.7
Yes	Ramp Width (in)	48.0	Yes	Ramp XSlope (%)	0.1
N/A	Flare Type LT	N/A	N/A	Flare Type RT	N/A
N/A	Flare Slope LT (%)	N/A	N/A	Flare Slope RT (%)	N/A
N/A	Flare Traversable LT?	N/A	N/A	Flare Traversable RT?	N/A
N/A	Landing Length (in)	N/A	N/A	DWS Provided?	N/A
N/A	Landing Width (in)	N/A	N/A	DWS Contrast?	N/A
N/A	Landing Slope (%)	N/A	N/A	DWS Length (in)	N/A
N/A	Landing X Slope (%)	N/A	N/A	DWS Full Width?	N/A
N/A	Landing Curb? (Y/N)	N/A	N/A	DWS Offset (in)	N/A
N/A	Shared Landing?	N/A			
N/A	Gutter Ponding?	N/A	N/A	Gutter Slope (%)	N/A
N/A	Gutter Lip Ht (in)	N/A	N/A	Gutter X Slope (%)	N/A
N/A	Painted X Walk1?	No	N/A	Painted X Walk2?	N/A
	X Walk 1 Direction	To SE		X Walk 2 Direction	N/A
N/A	X Walk 1 Width (in)	N/A	N/A	X Walk 2 Width (in)	N/A
	X Walk 1 Slope (%)	1.4		X Walk 2 Slope (%)	N/A
	X Walk 1 X Slope (%)	0.3		X Walk 2 X Slope (%)	N/A

N/A	Ramp inside XWalk1?	N/A	N/A	Ramp inside XWalk2?	N/A
	Road Slope (%)	N/A	N/A	Clear Space?	N/A
	Road X Slope (%)	N/A	N/A	Clear Space to XWalk (in)	N/A
N/A	Any Obstructions?	N/A	N/A	Storm Grate/Utility Hazard?	N/A
	Obstruction Type			Storm Grate/Utility Type	
		N/A			N/A
			Yes	Surface Condition? (G/P)	Good

Remove & Replace Entire Ramp.
