Access Compliance Report

Public Rights-of-Way

(Curb Ramps)

Intersection ID: 29174	Main Street: BIG_LEAF_DR	Cross Street: CHRUDAN_DR	Location: NW
ADA ID: C395134969E3	Ramp Type: PerpDiag	Initial Pass/Fail: Fail	Overall Compliance: No
			Severity Score: 46.25

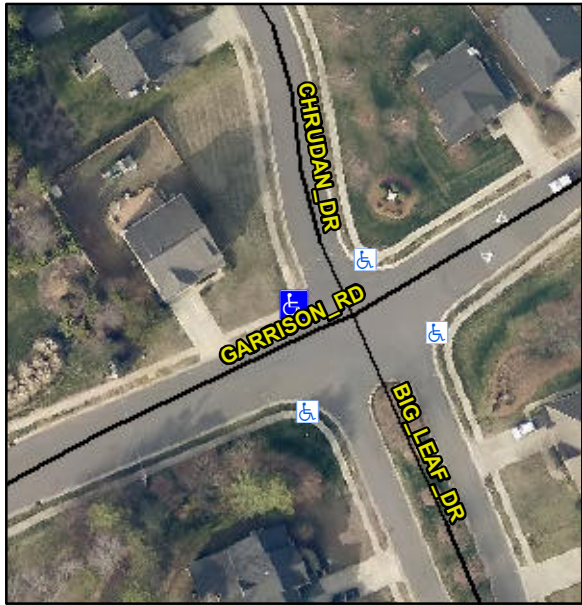
Possible Solutions:		Compliance	Description	Data	Compliance	Description	Data
	Remove & Replace Curb Ramp With Two New Directional Ramps or Equivalent.		N/A	Ramp Length (in)	49.0	No	Ramp Slope (%)	8.4
			No	Ramp Width (in)	41.0	No	Ramp XSlope (%)	7.2
			N/A	Flare Type LT	N/A	N/A	Flare Type RT	N/A
			N/A	Flare Slope LT (%)	N/A	N/A	Flare Slope RT (%)	N/A
			N/A	Flare Traversable LT?	N/A	N/A	Flare Traversable RT?	N/A
			N/A	Landing Length (in)	N/A	N/A	DWS Provided?	N/A
			N/A	Landing Width (in)	N/A	N/A	DWS Contrast?	N/A
			N/A	Landing Slope (%)	N/A	N/A	DWS Length (in)	N/A
			N/A	Landing X Slope (%)	N/A	N/A	DWS Full Width?	N/A
Surveyor Notes:			N/A	Landing Curb? (Y/N)	N/A	N/A	DWS Offset (in)	N/A
PROW/ADA:			N/A	Shared Landing?	N/A			
Not Found, R304.5.1, R304.2.2, R304.5.3			N/A	Gutter Ponding?	N/A	N/A	Gutter Slope (%)	N/A

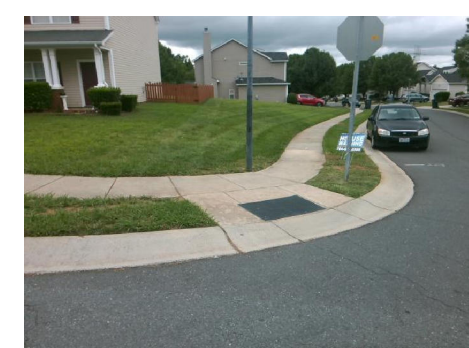
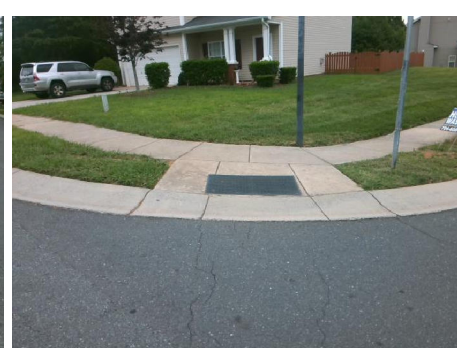
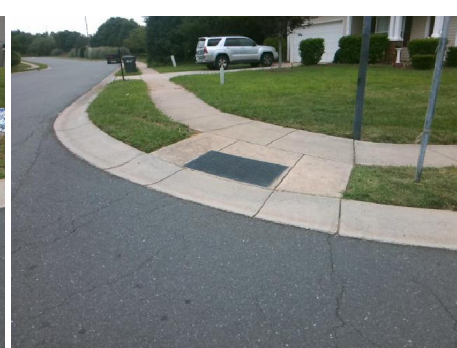
N/A	Gutter Lip Ht (in)	N/A	N/A	Gutter X Slope (%)	N/A
			N/A	Painted X Walk1?	No	N/A	Painted X Walk2?	No
				X Walk 1 Direction	To S		X Walk 2 Direction	To E
			N/A	X Walk 1 Width (in)	N/A	N/A	X Walk 2 Width (in)	N/A
				X Walk 1 Slope (%)	5.3		X Walk 2 Slope (%)	2.4
				X Walk 1 X Slope (%)	4.5		X Walk 2 X Slope (%)	5.9
			N/A	Ramp inside XWalk1?	N/A	N/A	Ramp inside XWalk2?	N/A
				Road Slope (%)	7.9	N/A	Clear Space?	N/A
				Road X Slope (%)	1.3	N/A	Clear Space to XWalk (in)	N/A
			N/A	Any Obstructions?	N/A	N/A	Storm Grate/Utility Hazard?	N/A
				Obstruction Type			Storm Grate/Utility Type	
						N/A		N/A
						Yes	Surface Condition? (G/P)	Good
Total Cost:		\$ 3200.00						
Street 1 Name			GARRISON RD					
Stop Condition-Street 2			None					
Street 2 Name			CHRUDAN DR					
Stop Condition-Street 1			StopSign
