Intersection ID: 52449		Main Street: TRANQUIL_OAK_PL		Cross Street: PAT_GARRETT_ST		Location:		SE							
ADA ID: C3976E673E15		Ramp Type: Directional1		Initial Pass/Fail: Fail		Overall Compliance: No		Severity Score: 13.75							
Codes/Mitigation Info/Possible Solution				Field Measurements/Component Compliance											
<div>

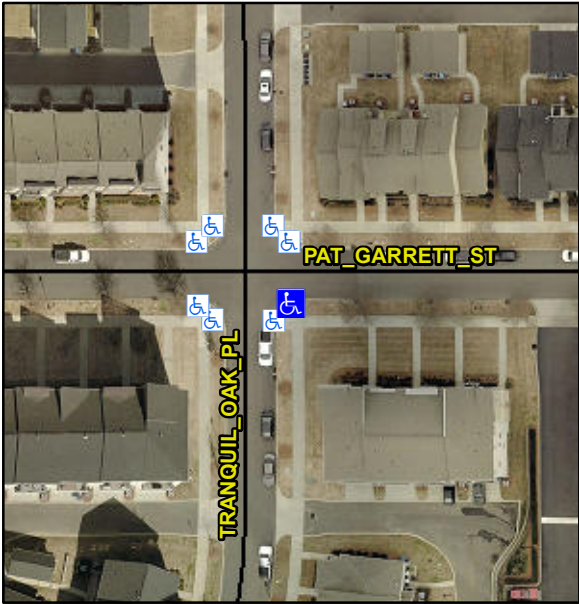
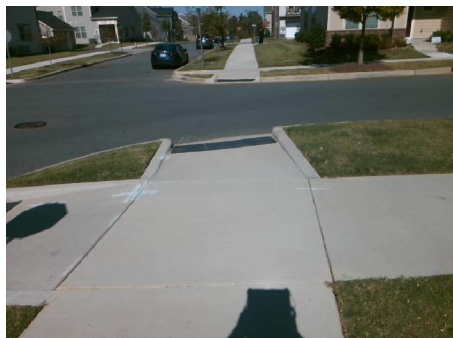
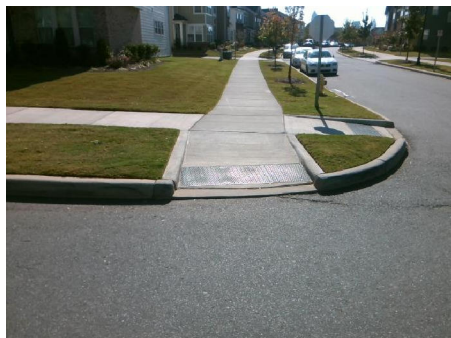
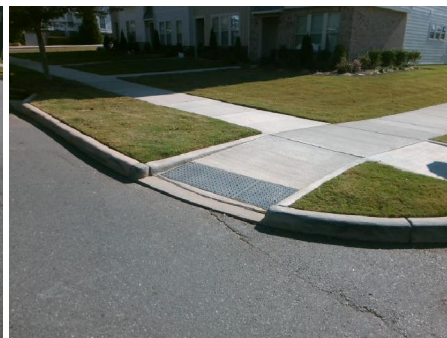
<div>Possible Solutions: Remove & Replace Entire Ramp.</div><div>Surveyor Notes: N/A</div><div>PROW/ADA: R304.2.2, R304.5.3</div></div> <td colspan="2">Compliance</td> <td colspan="2">Description</td> <td colspan="2">Data</td> <td colspan="2">Compliance</td> <td colspan="2">Description</td> <td colspan="2">Data</td>				Compliance		Description		Data		Compliance		Description		Data	
				N/A		Ramp Length (in)		84.0	N/A		Grade Break?		N/A		0.0
Yes		Ramp Width (in)		68.0	N/A		Grade Break Slope (%)		N/A		0.0				
No		Ramp Slope (%)		10.1	N/A		Grade Break XSlope (%)		N/A		0.0

No		Ramp XSlope (%)		3.3											
N/A		Flare Type LT		N/A	N/A		Flare Type RT		N/A		N/A				
N/A		Flare Slope LT (%)		N/A	N/A		Flare Slope RT (%)		N/A		0.0				
N/A		Flare Traversable LT?		N/A	N/A		Flare Traversable RT?		N/A		N/A				
N/A		Landing Length (in)		0.0	N/A		DWS Provided?		N/A		N/A				
N/A		Landing Width (in)		0.0	N/A		DWS Contrast?		N/A		N/A				
N/A		Landing Slope (%)		0.0	N/A		DWS Length (in)		N/A		N/A				
N/A		Landing X Slope (%)		0.0	N/A		DWS Full Width?		N/A		N/A				
N/A		Landing Curb? (Y/N)		N/A	N/A		DWS Offset LT (in)		N/A		N/A				
N/A		Shared Landing?		N/A	N/A		DWS Offset RT (in)		N/A		N/A				
N/A		Gutter Ponding?		0.0	N/A		Gutter Slope (%)		N/A		N/A				
N/A		Gutter Lip Ht (in)		1.0	N/A		Gutter X Slope (%)		N/A		N/A				
N/A		Painted X Walk1?		No			Road Slope (%)				2.1				
		X Walk 1 Direction		To N			Road X Slope (%)				2.0				
		X Walk 1 Width (in)		N/A			Clear Space?				N/A				
		X Walk 1 Slope (%)		2.1	N/A		Clear Space to XWalk (in)		N/A		N/A

X Walk 1 X Slope (%)		2.0	N/A		Storm Grate/Utility Hazard?		N/A		N/A				
N/A		Ramp inside XWalk1?		N/A			Storm Grate/Utility Type								
N/A		Any Obstructions?		N/A							N/A				
		Obstruction Type			Yes		Surface Condition? (G/P)		Good						
				N/A	N/A		Curb Slope (%)		3.6						
Total Cost:				\$	1600.00
