Access Compliance Report

Public Rights-of-Way

(Curb Ramps)

Intersection ID: 17062	Main Street: IDLEWILD_RD	Cross Street: MONROE_RD	Location: SE
ADA ID: C39B56454FEF	Ramp Type: BlendTrans1	Initial Pass/Fail: Fail	Overall Compliance: No
Severity Score: 12.5			
Codes/Mitigation Info/Possible Solution		Field Measurements/Component Compliance

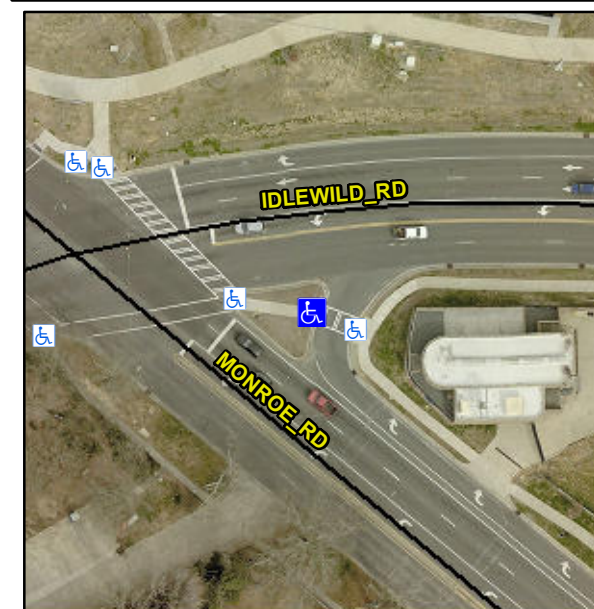
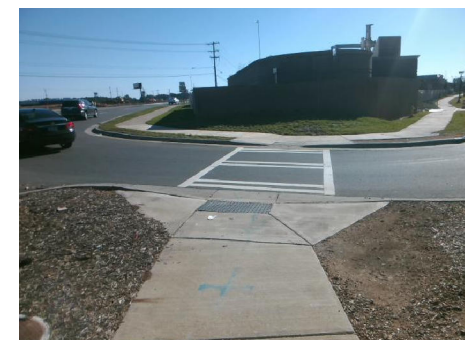
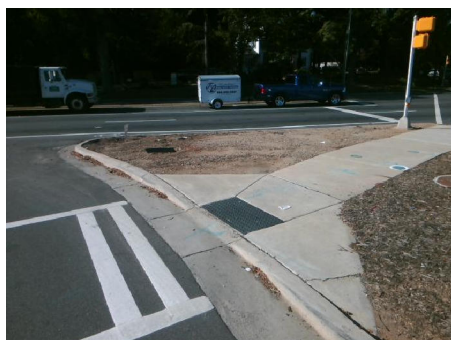
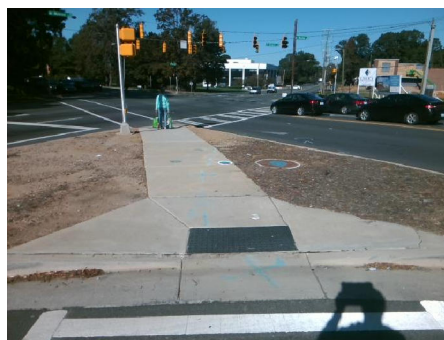
Not Found, R304.5.3

Compliance	Description	Data	Compliance	Description	Data
N/A	Ramp Length (in)	68.0	Yes	BlendTrans Slope (%)	3.8
Yes	Ramp Width (in)	48.0	No	BlendTrans XSlope (%)	5.3
N/A	Flare Type LT	N/A	N/A	Flare Type RT	N/A
N/A	Flare Slope LT (%)	N/A	N/A	Flare Slope RT (%)	N/A
N/A	Flare Traversable LT?	N/A	N/A	Flare Traversable RT?	N/A
N/A	Landing Length (in)	N/A	N/A	DWS Provided?	N/A
N/A	Landing Width (in)	N/A	N/A	DWS Contrast?	N/A
N/A	Landing Slope (%)	N/A	N/A	DWS Length (in)	N/A
N/A	Landing X Slope (%)	N/A	N/A	DWS Full Width?	N/A
N/A	Landing Curb? (Y/N)	N/A	N/A	DWS Offset (in)	N/A
N/A	Shared Landing?	N/A			
N/A	Gutter Ponding?	N/A	N/A	Gutter Slope (%)	N/A
N/A	Gutter Lip Ht (in)	N/A	N/A	Gutter X Slope (%)	N/A
N/A	Painted X Walk1?	Yes	N/A	Painted X Walk2?	N/A
	X Walk 1 Direction	To SE		X Walk 2 Direction	N/A
	X Walk 1 Width (in)	112.0		X Walk 2 Width (in)	N/A
	X Walk 1 Slope (%)	0.4		X Walk 2 Slope (%)	N/A
	X Walk 1 X Slope (%)	4.7		X Walk 2 X Slope (%)	N/A

N/A	Ramp inside XWalk1?	Yes	N/A	Ramp inside XWalk2?	N/A
	Road Slope (%)	4.7		Clear Space?	N/A
	Road X Slope (%)	0.4	N/A	Clear Space to XWalk (in)	N/A
N/A	Any Obstructions?	N/A	N/A	Storm Grate/Utility Hazard?	N/A
	Obstruction Type			Storm Grate/Utility Type	
		N/A			N/A
			Yes	Surface Condition? (G/P)	Good
			No	Curb Slope (%)	6.1

Possible Solutions:

Remove & Replace Curb Ramp With Two New Directional Ramps or Equivalent.
