Access Compliance Report Public Rights-of-Way (Curb Ramps)

Cross Street: PARK RD Intersection ID: 18654 Main Street: ESTATES AV Location: SW Initial Pass/Fail: Fail **Overall Compliance: No** ADA ID: C39B9D96D4AA Ramp Type: PerpDiag Severity Score: 21.25

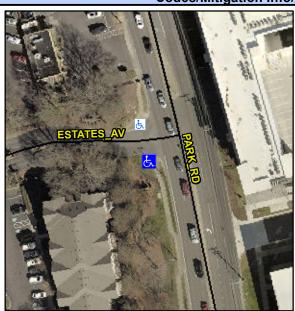
Street 1 Name **PARK RD** Stop Condition-Street 2 None **ESTATES AV** Street 2 Name Stop Condition-Street 1 StopSign Possible Solutions: Compliance Description N/A Remove & Replace Curb Ramp With Two New Directional Ramps or Equivalent. Surveyor Notes: N/A PROW/ADA: Not Found, R304.5.1, R304.2.2

Yes No Ramp Width (in) 39.0 Ramp XSlope (%) N/A N/A Flare Type LT N/A Flare Type RT N/A N/A N/A Flare Slope RT (%) Flare Slope LT (%) N/A Flare Traversable LT? N/A N/A Flare Traversable RT? N/A N/A N/A **DWS Provided?** Landing Length (in) N/A Landing Width (in) N/A N/A **DWS Contrast?** N/A N/A N/A Landing Slope (%) DWS Length (in) N/A Landing X Slope (%) N/A N/A DWS Full Width? N/A Landing Curb? (Y/N) N/A N/A DWS Offset (in) N/A N/A Shared Landing? N/A **Gutter Ponding?** N/A N/A Gutter Slope (%) N/A Gutter Lip Ht (in) N/A N/A Gutter X Slope (%) N/A Painted X Walk1? No N/A Painted X Walk2? X Walk 1 Direction To E X Walk 2 Direction N/A N/A X Walk 1 Width (in) X Walk 2 Width (in) X Walk 1 Slope (%) X Walk 2 Slope (%) 1.4 X Walk 1 X Slope (%) 2.8 X Walk 2 X Slope (%) N/A N/A N/A Ramp inside XWalk2? Ramp inside XWalk1? Road Slope (%) 0.0 N/A Clear Space? N/A Road X Slope (%) 3.3 Clear Space to XWalk (in) N/A N/A N/A Any Obstructions? Storm Grate/Utility Hazard? **Obstruction Type** Storm Grate/Utility Type N/A
