# Access Compliance Report

## Public Rights-of-Way

### (Curb Ramps)

| Intersection ID: 21952 | Main Street: AUTUMN_BLAZE_DR | Cross Street: SHADEMASTER_PL | Location: W |

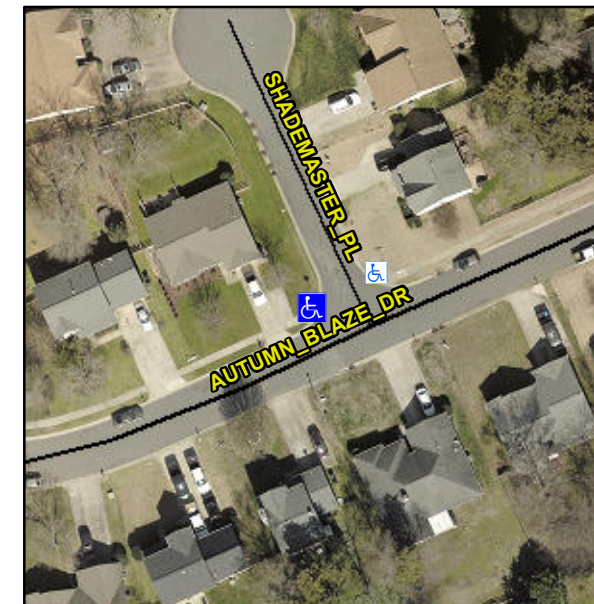
| ADA ID: C39BB458E58D | Ramp Type: Directional1 | Initial Pass/Fail: Fail | Overall Compliance: No |
| Severity Score: 12.5 | | | |

**R304.2.2**

| Compliance | Description | Data | Compliance | Description | Data |
|---|---|---|---|---|---|
| No | Ramp Slope (%) | 8.8 | N/A | Grade Break XSlope (%) | 0.0 |

**Remove & Replace Entire Ramp.**

\$ 1600.00
