# Access Compliance Report

## Public Rights-of-Way

### (Curb Ramps)

Intersection ID: 14925	Main Street: BROMLEY_RD	Cross Street: QUEENS_RD	Location: NW
ADA ID: C39F8AA8D352	Ramp Type: Perp	Initial Pass/Fail: Fail	Overall Compliance: No
		Severity Score: 50

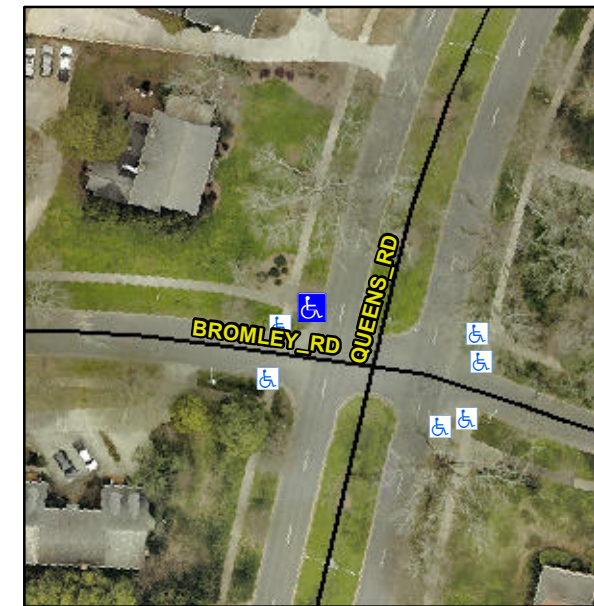
**Not Found, R304.2.2, R304.5.3**

Compliance	Description	Data	Compliance	Description	Data
N/A	Ramp Length (in)	52.0	No	Ramp Slope (%)	18.7
Yes	Ramp Width (in)	48.0	No	Ramp XSlope (%)	8.7
N/A	Flare Type LT	N/A	N/A	Flare Type RT	N/A
N/A	Flare Slope LT (%)	N/A	N/A	Flare Slope RT (%)	N/A
N/A	Flare Traversable LT?	N/A	N/A	Flare Traversable RT?	N/A
N/A	Landing Length (in)	N/A	N/A	DWS Provided?	N/A
N/A	Landing Width (in)	N/A	N/A	DWS Contrast?	N/A
N/A	Landing Slope (%)	N/A	N/A	DWS Length (in)	N/A
N/A	Landing X Slope (%)	N/A	N/A	DWS Full Width?	N/A
N/A	Landing Curb? (Y/N)	N/A	N/A	DWS Offset (in)	N/A
N/A	Shared Landing?	N/A			
N/A	Gutter Ponding?	N/A	N/A	Gutter Slope (%)	N/A
N/A	Gutter Lip Ht (in)	N/A	N/A	Gutter X Slope (%)	N/A
N/A	Painted X Walk1?	No	N/A	Painted X Walk2?	N/A
	X Walk 1 Direction	To SE		X Walk 2 Direction	N/A
N/A	X Walk 1 Width (in)	N/A	N/A	X Walk 2 Width (in)	N/A
	X Walk 1 Slope (%)	5.3		X Walk 2 Slope (%)	N/A
	X Walk 1 X Slope (%)	1.9		X Walk 2 X Slope (%)	N/A

**Remove & Replace Entire Ramp.**

Total Cost: \$ 1850.00
