# Access Compliance Report

## Public Rights-of-Way

### (Curb Ramps)

Intersection ID: 43839	Main Street: DELUCA_DR	Cross Street: HAMEL_ST	Location: SW
ADA ID: C3AC0C685539	Ramp Type: Perp	Initial Pass/Fail: Pass	Overall Compliance: No
Codes/Mitigation Info/Possible Solution		Field Measurements/Component Compliance	
Severity Score: 7.5

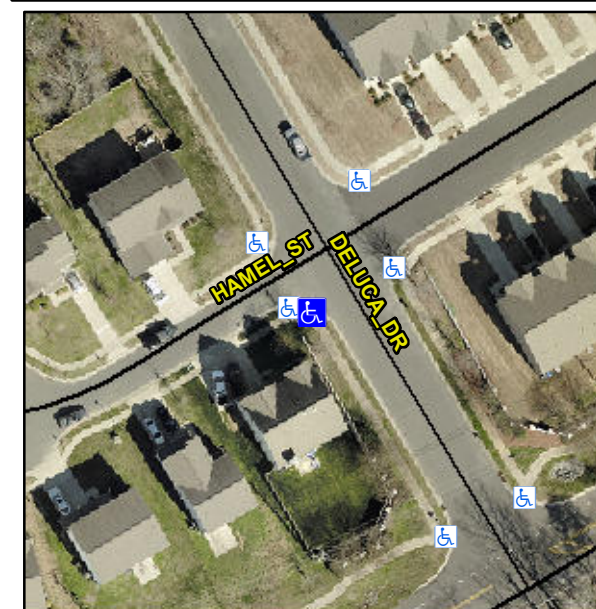
Compliance	Description	Data	Compliance	Description	Data
N/A	Ramp Length (in)	45.0	Yes	Ramp Slope (%)	7.1
Yes	Ramp Width (in)	48.0	Yes	Ramp XSlope (%)	0.9
N/A	Flare Type LT	Sloped	N/A	Flare Type RT	N/A
N/A	Flare Slope LT (%)	3.6	N/A	Flare Slope RT (%)	3.2
N/A	Flare Traversable LT?	No	N/A	Flare Traversable RT?	No
Yes	Landing Length (in)	56.5	Yes	DWS Provided?	Yes
Yes	Landing Width (in)	48.0	Yes	DWS Contrast?	Yes
No	Landing Slope (%)	2.2	Yes	DWS Length (in)	24.0
Yes	Landing X Slope (%)	0.5	No	DWS Full Width?	No
N/A	Landing Curb? (Y/N)	No	No	DWS Offset (in)	5.5
N/A	Shared Landing?	No			
Yes	Gutter Ponding?	No	No	Gutter Slope (%)	10.9
Yes	Gutter Lip Ht (in)	0.0	No	Gutter X Slope (%)	3.1
N/A	Painted X Walk1?	No	N/A	Painted X Walk2?	N/A
	X Walk 1 Direction	To E		X Walk 2 Direction	N/A
N/A	X Walk 1 Width (in)	N/A	N/A	X Walk 2 Width (in)	N/A
	X Walk 1 Slope (%)	1.7		X Walk 2 Slope (%)	N/A
	X Walk 1 X Slope (%)	2.7		X Walk 2 X Slope (%)	N/A

N/A	Ramp inside XWalk1?	N/A	N/A	Ramp inside XWalk2?	N/A
	Road Slope (%)	N/A	N/A	Clear Space?	Yes
	Road X Slope (%)	N/A	N/A	Clear Space to XWalk (in)	N/A
Yes	Any Obstructions?	No	Yes	Storm Grate/Utility Hazard?	No
	Obstruction Type			Storm Grate/Utility Type	
		N/A			N/A
			Yes	Surface Condition? (G/P)	Good

Possible Solutions:

**Remove & Replace Entire Ramp.  
Remove & Replace Gutter.**
