Access Compliance Report

Public Rights-of-Way

(Curb Ramps)

Intersection ID: 20634	Main Street: COVEDALE_DR	Cross Street: MONROE_RD	Location: S
ADA ID: C3B177E6B7D9	Ramp Type: PerpDiag	Initial Pass/Fail: Fail	Overall Compliance: No
Severity Score: 12.5			
Codes/Mitigation Info/Possible Solution		Field Measurements/Component Compliance

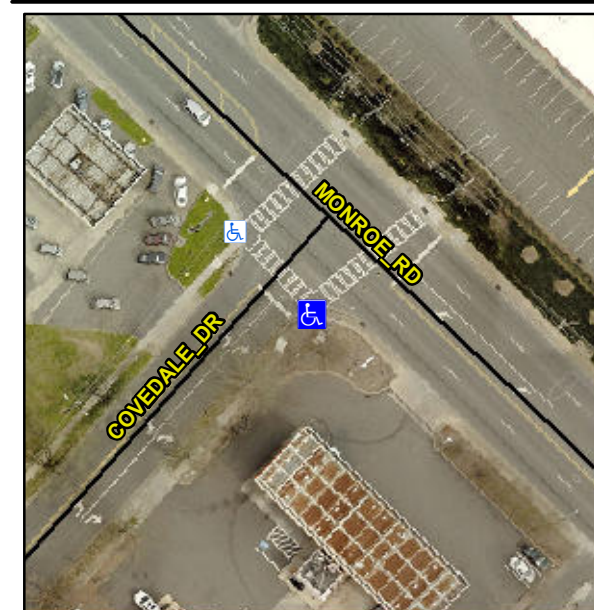
Not Found, R304.2.2

Compliance	Description	Data	Compliance	Description	Data
N/A	Ramp Length (in)	61.0	No	Ramp Slope (%)	11.9
Yes	Ramp Width (in)	48.0	Yes	Ramp XSlope (%)	0.5
N/A	Flare Type LT	N/A	N/A	Flare Type RT	N/A
N/A	Flare Slope LT (%)	N/A	N/A	Flare Slope RT (%)	N/A
N/A	Flare Traversable LT?	N/A	N/A	Flare Traversable RT?	N/A
N/A	Landing Length (in)	N/A	N/A	DWS Provided?	N/A
N/A	Landing Width (in)	N/A	N/A	DWS Contrast?	N/A
N/A	Landing Slope (%)	N/A	N/A	DWS Length (in)	N/A
N/A	Landing X Slope (%)	N/A	N/A	DWS Full Width?	N/A
N/A	Landing Curb? (Y/N)	N/A	N/A	DWS Offset (in)	N/A
N/A	Shared Landing?	N/A			
N/A	Gutter Ponding?	N/A	N/A	Gutter Slope (%)	N/A
N/A	Gutter Lip Ht (in)	N/A	N/A	Gutter X Slope (%)	N/A
N/A	Painted X Walk1?	No	N/A	Painted X Walk2?	No
	X Walk 1 Direction	To NE		X Walk 2 Direction	To NW
N/A	X Walk 1 Width (in)	N/A	N/A	X Walk 2 Width (in)	N/A
	X Walk 1 Slope (%)	0.0		X Walk 2 Slope (%)	2.0
	X Walk 1 X Slope (%)	1.5		X Walk 2 X Slope (%)	0.2

N/A	Ramp inside XWalk1?	N/A	N/A	Ramp inside XWalk2?	N/A
	Road Slope (%)	0.3	N/A	Clear Space?	N/A
	Road X Slope (%)	2.2	N/A	Clear Space to XWalk (in)	N/A
N/A	Any Obstructions?	N/A	N/A	Storm Grate/Utility Hazard?	N/A
	Obstruction Type			Storm Grate/Utility Type	
		N/A			N/A
			Yes	Surface Condition? (G/P)	Good

Remove & Replace Curb Ramp With Two New Directional Ramps or Equivalent.

Total Cost: \$ 3200.00
