Access Compliance Report

Public Rights-of-Way

(Curb Ramps)

Intersection ID: 28021	Main Street: OLD_CORRAL_ST	Cross Street: TAOS_CT	Location: SE
ADA ID: C3C7B01932A1	Ramp Type: BlendTrans2	Initial Pass/Fail: Pass	Overall Compliance: No
Severity Score: 25			
Codes/Mitigation Info/Possible Solution		Field Measurements/Component Compliance

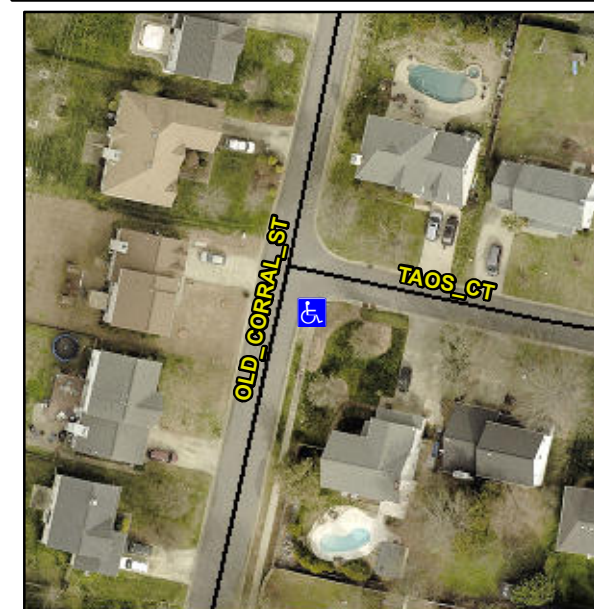
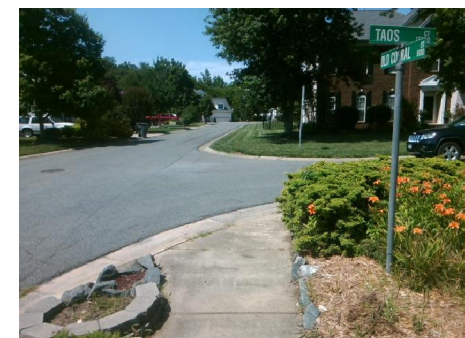
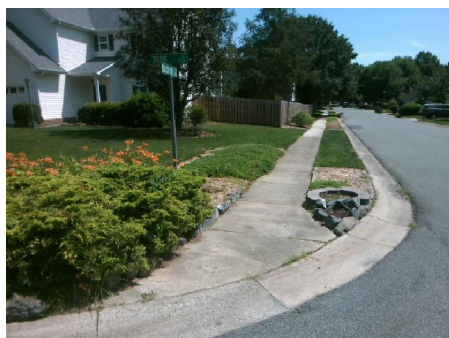
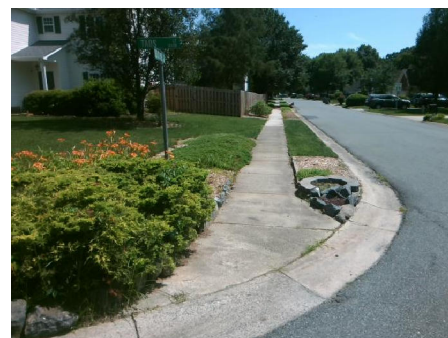
Not Found, R305, R302.7.2

Compliance	Description	Data	Compliance	Description	Data
N/A	Ramp Length (in)	54.0	Yes	BlendTrans Slope (%)	3.5
Yes	Ramp Width (in)	48.0	Yes	BlendTrans XSlope (%)	1.4
N/A	Flare Type LT	None	N/A	Flare Type RT	None
N/A	Flare Slope LT (%)	N/A	N/A	Flare Slope RT (%)	N/A
N/A	Flare Traversable LT?	N/A	N/A	Flare Traversable RT?	N/A
N/A	Landing Length (in)	N/A	No	DWS Provided?	No
N/A	Landing Width (in)	N/A	N/A	DWS Contrast?	No
N/A	Landing Slope (%)	N/A	N/A	DWS Length (in)	N/A
N/A	Landing X Slope (%)	N/A	N/A	DWS Full Width?	No
N/A	Landing Curb? (Y/N)	No	N/A	DWS Offset (in)	N/A
N/A	Shared Landing?	No			
Yes	Gutter Ponding?	No	Yes	Gutter Slope (%)	4.4
No	Gutter Lip Ht (in)	1.0	Yes	Gutter X Slope (%)	1.9
N/A	Painted X Walk1?	No	N/A	Painted X Walk2?	No
	X Walk 1 Direction	To NE		X Walk 2 Direction	To NW
	X Walk 1 Width (in)	N/A		X Walk 2 Width (in)	N/A
	X Walk 1 Slope (%)	1.4		X Walk 2 Slope (%)	2.4
	X Walk 1 X Slope (%)	2.4		X Walk 2 X Slope (%)	1.5

N/A	Ramp inside XWalk1?	N/A	N/A	Ramp inside XWalk2?	N/A
	Road Slope (%)	0.5		Clear Space?	Yes
	Road X Slope (%)	4.0	N/A	Clear Space to XWalk (in)	N/A
Yes	Any Obstructions?	No	Yes	Storm Grate/Utility Hazard?	No
	Obstruction Type			Storm Grate/Utility Type	
		N/A			N/A
			Yes	Surface Condition? (G/P)	Good
			No	Curb Slope (%)	6.7

Possible Solutions:

Remove & Replace Curb Ramp With Two New Directional Ramps or Equivalent.
