# Access Compliance Report

## Public Rights-of-Way

### (Curb Ramps)

| Intersection ID: 54372 | Main Street: ARNOTT_LN | Cross Street: CALLONWOOD_DR | Location: SW |

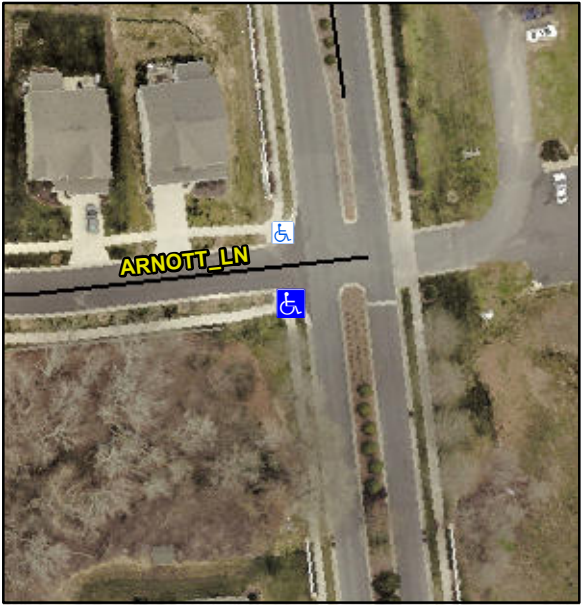
| ADA ID: C3CC8F7965E9 | Ramp Type: Perp | Initial Pass/Fail: Fail | Overall Compliance: No |

| Codes/Mitigation Info/Possible Solution | | | Field Measurements/Component Compliance | | |
|---|---|--|---|---|---|
| | | | <b>No</b> | Ramp Width (in) | <b>47.0</b> |
| <p>Surveyor Notes:</p> <p><b>N/A</b></p> <p>PROW/ADA:</p> <p><b>Not Found, R304.5.1, R304.5.3</b></p> | | | <b>N/A</b> | Flare Type RT | <b>N/A</b> |

| Codes/Mitigation Info/Possible Solution | | | Field Measurements/Component Compliance | | |
|---|---|--|---|---|---|
| | <b>Remove &amp; Replace Entire Ramp.</b> | | <b>N/A</b> | Ramp Length (in) | <b>63.5</b> |
| <p>Total Cost:</p> <p><b>\$ 1850.00</b></p> | | | <b>No</b> | Painted X Walk2? | <b>N/A</b> |
