Access Compliance Report

Public Rights-of-Way

(Curb Ramps)

Intersection ID: 47659	Main Street: FENWAY_DR	Cross Street: WRIGLEY_DR	Location: SW
ADA ID: C3D0D4D50F93	Ramp Type: PerpDiag	Initial Pass/Fail: Fail	Overall Compliance: No
Severity Score: 10			
Codes/Mitigation Info/Possible Solution		Field Measurements/Component Compliance

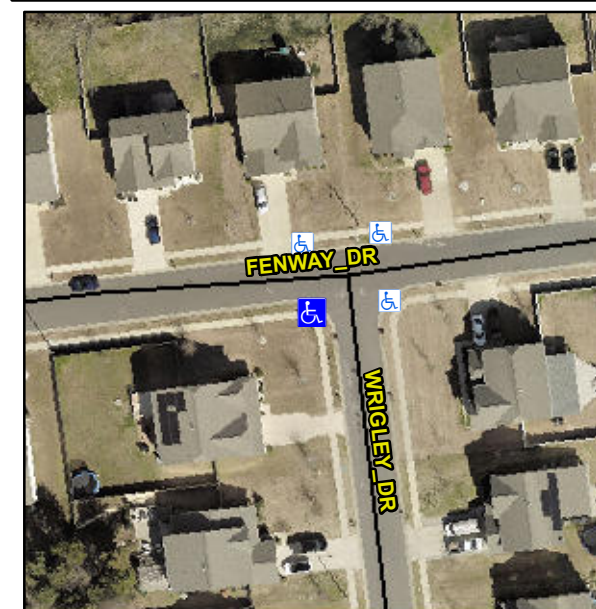
Compliance	Description	Data	Compliance	Description	Data
N/A	Ramp Length (in)	48.0	Yes	Ramp Slope (%)	6.0
No	Ramp Width (in)	46.0	No	Ramp XSlope (%)	2.3
N/A	Flare Type LT	N/A	N/A	Flare Type RT	N/A
N/A	Flare Slope LT (%)	N/A	N/A	Flare Slope RT (%)	N/A
N/A	Flare Traversable LT?	N/A	N/A	Flare Traversable RT?	N/A
N/A	Landing Length (in)	N/A	N/A	DWS Provided?	N/A
N/A	Landing Width (in)	N/A	N/A	DWS Contrast?	N/A
N/A	Landing Slope (%)	N/A	N/A	DWS Length (in)	N/A
N/A	Landing X Slope (%)	N/A	N/A	DWS Full Width?	N/A
N/A	Landing Curb? (Y/N)	N/A	N/A	DWS Offset (in)	N/A
N/A	Shared Landing?	N/A			
N/A	Gutter Ponding?	N/A	N/A	Gutter Slope (%)	N/A
N/A	Gutter Lip Ht (in)	N/A	N/A	Gutter X Slope (%)	N/A
N/A	Painted X Walk1?	No	N/A	Painted X Walk2?	No
	X Walk 1 Direction	To E		X Walk 2 Direction	To N
N/A	X Walk 1 Width (in)	N/A	N/A	X Walk 2 Width (in)	N/A
	X Walk 1 Slope (%)	6.3		X Walk 2 Slope (%)	1.4
	X Walk 1 X Slope (%)	0.6		X Walk 2 X Slope (%)	3.7

N/A	Ramp inside XWalk1?	N/A	N/A	Ramp inside XWalk2?	N/A
	Road Slope (%)	2.9	N/A	Clear Space?	N/A
	Road X Slope (%)	4.2	N/A	Clear Space to XWalk (in)	N/A
N/A	Any Obstructions?	N/A	N/A	Storm Grate/Utility Hazard?	N/A
	Obstruction Type			Storm Grate/Utility Type	
		N/A			N/A
		Yes		Surface Condition? (G/P)	Good

Possible Solutions:

Remove & Replace Curb Ramp With Two New Directional Ramps or Equivalent.

Not Found, R304.5.1, R304.5.3
