Access Compliance Report

Public Rights-of-Way

(Curb Ramps)

Intersection ID: 2731	Main Street: TANAGER_LN	Cross Street: VIREO_CT	Location: SW
ADA ID: C3D21AA2F56C	Ramp Type: Perp	Initial Pass/Fail: Fail	Overall Compliance: No
Severity Score: 10			
Codes/Mitigation Info/Possible Solution		Field Measurements/Component Compliance

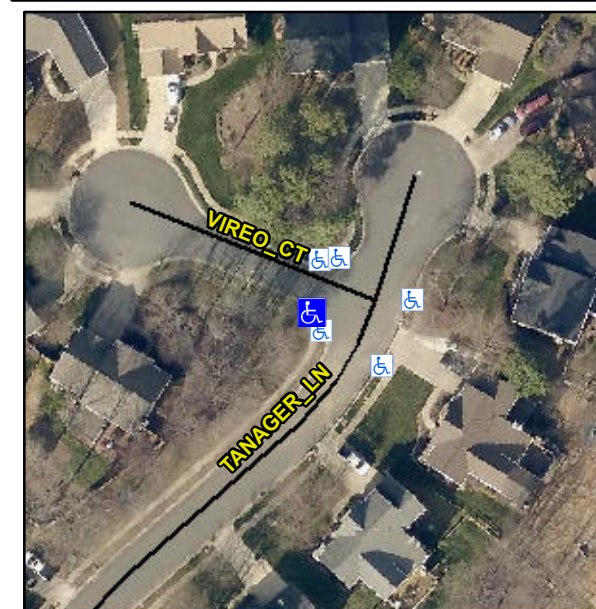
R304.5.1, R304.5.3

Compliance	Description	Data	Compliance	Description	Data
N/A	Ramp Length (in)	48.0	Yes	Ramp Slope (%)	5.3
No	Ramp Width (in)	41.0	No	Ramp XSlope (%)	4.3
N/A	Flare Type LT	N/A	N/A	Flare Type RT	N/A
N/A	Flare Slope LT (%)	N/A	N/A	Flare Slope RT (%)	N/A
N/A	Flare Traversable LT?	N/A	N/A	Flare Traversable RT?	N/A
N/A	Landing Length (in)	N/A	N/A	DWS Provided?	N/A
N/A	Landing Width (in)	N/A	N/A	DWS Contrast?	N/A
N/A	Landing Slope (%)	N/A	N/A	DWS Length (in)	N/A
N/A	Landing X Slope (%)	N/A	N/A	DWS Full Width?	N/A
N/A	Landing Curb? (Y/N)	N/A	N/A	DWS Offset (in)	N/A
N/A	Shared Landing?	N/A			
N/A	Gutter Ponding?	N/A	N/A	Gutter Slope (%)	N/A
N/A	Gutter Lip Ht (in)	N/A	N/A	Gutter X Slope (%)	N/A
N/A	Painted X Walk1?	No	N/A	Painted X Walk2?	N/A
	X Walk 1 Direction	To NE		X Walk 2 Direction	N/A
N/A	X Walk 1 Width (in)	N/A	N/A	X Walk 2 Width (in)	N/A
	X Walk 1 Slope (%)	2.7		X Walk 2 Slope (%)	N/A
	X Walk 1 X Slope (%)	5.0		X Walk 2 X Slope (%)	N/A

Remove & Replace Entire Ramp.
