## Access Compliance Report Public Rights-of-Way (Curb Ramps)

Intersection ID: 10040202 Main Street: TYVOLA\_RD Cross Street: N/A Location: SE

ADA ID: C3DC37901AFA Ramp Type: PerpDiag Initial Pass/Fail: Fail Overall Compliance: No Severity Score: 12.5

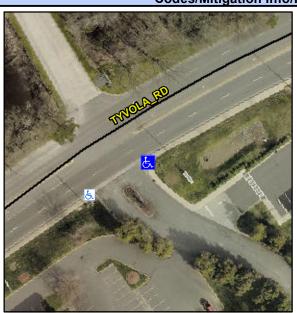
Comp	oliance Description	Data	Comp	oliance	Description	Data
N/A	Ramp Length (in)	77.0	Yes	Ramp	Slope (%)	7.1
Yes	Ramp Width (in)	48.0	No	Ramp	XSlope (%)	5.1
N/A	Flare Type LT	N/A	N/A	Flare 1	Гуре RT	N/A
N/A	Flare Slope LT (%)	N/A	N/A	Flare S	Slope RT (%)	N/A
N/A	Flare Traversable LT?	N/A	N/A	Flare 1	Traversable RT?	N/A
N/A	Landing Length (in)	N/A	N/A	DWS I	Provided?	N/A
N/A	Landing Width (in)	N/A	N/A	DWS (	Contrast?	N/A
N/A	Landing Slope (%)	N/A	N/A	DWS I	Length (in)	N/A
N/A	Landing X Slope (%)	N/A	N/A	DWS I	Full Width?	N/A
N/A	Landing Curb? (Y/N)	N/A	N/A	DWS (	Offset (in)	N/A
N/A	Shared Landing?	N/A				
N/A	Gutter Ponding?	N/A	N/A	Gutter	Slope (%)	N/A
N/A	Gutter Lip Ht (in)	N/A	N/A	Gutter	X Slope (%)	N/A
N/A	Painted X Walk1?	No	N/A	Painte	d X Walk2?	No
	X Walk 1 Direction	To NW		X Wall	c 2 Direction	To SW
N/A	X Walk 1 Width (in)	N/A	N/A	X Wall	c 2 Width (in)	N/A
	X Walk 1 Slope (%)	0.1		X Wall	< 2 Slope (%)	4.5

X Walk 1 X Slope (%)	0.3		X Wall	< 2 X Slope (%)	4.6
N/A	Ramp inside XWalk1?	N/A	N/A	Ramp	inside XWalk2?	N/A
	Road Slope (%)	4.3	N/A	Clear	Space?	N/A
	Road X Slope (%)	0.4	N/A	Clear	Space to XWalk (in)	N/A
N/A	Any Obstructions?	N/A	N/A	Storm	Grate/Utility Hazard?	N/A
	Obstruction Type			Storm	Grate/Utility Type	
		N/A				N/A

Remove & Replace Curb Ramp With Two New Directional Ramps or Equivalent.

R304.5.3
