# Access Compliance Report

## Public Rights-of-Way

### (Curb Ramps)

Intersection ID: 9899	Main Street: TUCKASEEGEE_RD	Cross Street: N/A	Location: SW
ADA ID: C3E0A2496667	Ramp Type: BlendTrans2	Initial Pass/Fail: Fail	Overall Compliance: No
Severity Score: 10			
Codes/Mitigation Info/Possible Solution		Field Measurements/Component Compliance

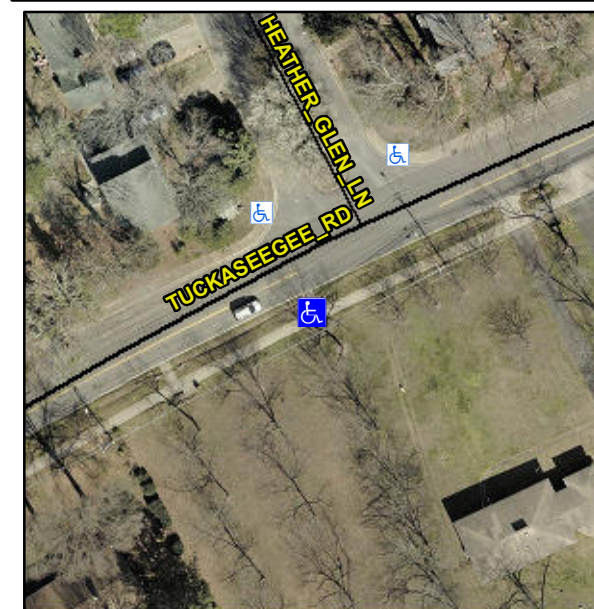
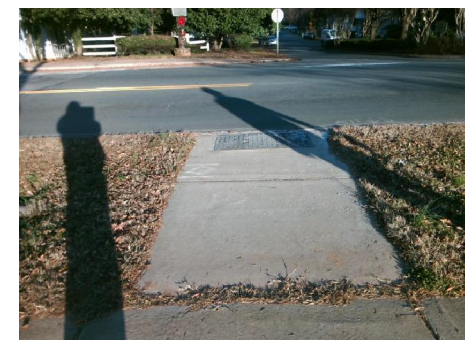
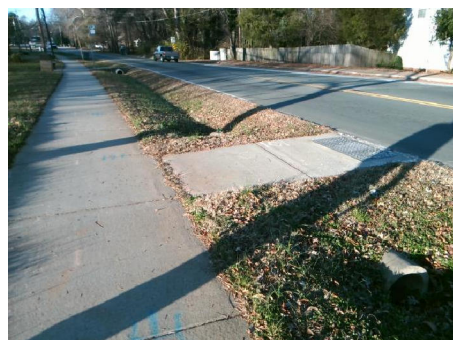
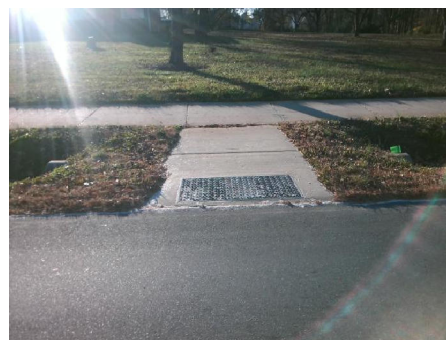
**R304.5.1, R304.5.3**

Compliance	Description	Data	Compliance	Description	Data
N/A	Ramp Length (in)	61.5	Yes	BlendTrans Slope (%)	1.5
No	Ramp Width (in)	47.5	No	BlendTrans XSlope (%)	2.4
N/A	Flare Type LT	N/A	N/A	Flare Type RT	N/A
N/A	Flare Slope LT (%)	N/A	N/A	Flare Slope RT (%)	N/A
N/A	Flare Traversable LT?	N/A	N/A	Flare Traversable RT?	N/A
N/A	Landing Length (in)	N/A	N/A	DWS Provided?	N/A
N/A	Landing Width (in)	N/A	N/A	DWS Contrast?	N/A
N/A	Landing Slope (%)	N/A	N/A	DWS Length (in)	N/A
N/A	Landing X Slope (%)	N/A	N/A	DWS Full Width?	N/A
N/A	Landing Curb? (Y/N)	N/A	N/A	DWS Offset (in)	N/A
N/A	Shared Landing?	N/A			
N/A	Gutter Ponding?	N/A	N/A	Gutter Slope (%)	N/A
N/A	Gutter Lip Ht (in)	N/A	N/A	Gutter X Slope (%)	N/A
N/A	Painted X Walk1?	No	N/A	Painted X Walk2?	N/A
	X Walk 1 Direction	To N		X Walk 2 Direction	N/A
	X Walk 1 Width (in)	N/A		X Walk 2 Width (in)	N/A
	X Walk 1 Slope (%)	1.5		X Walk 2 Slope (%)	N/A
	X Walk 1 X Slope (%)	1.9		X Walk 2 X Slope (%)	N/A

N/A	Ramp inside XWalk1?	N/A	N/A	Ramp inside XWalk2?	N/A
	Road Slope (%)	1.9		Clear Space?	N/A
	Road X Slope (%)	1.5	N/A	Clear Space to XWalk (in)	N/A
N/A	Any Obstructions?	N/A	N/A	Storm Grate/Utility Hazard?	N/A
	Obstruction Type			Storm Grate/Utility Type	
		N/A			N/A
			Yes	Surface Condition? (G/P)	Good
			N/A	Curb Slope (%)	0.1

**Remove & Replace Curb Ramp With Two New Directional Ramps or Equivalent.**

Total Cost: \$ 3200.00
