Access Compliance Report

Public Rights-of-Way

(Curb Ramps)

Intersection ID: 44447	Main Street: REAMES_RD	Cross Street: BAYVIEW_PY	Location: W
ADA ID: C3E97F53818E	Ramp Type: PerpDiag	Initial Pass/Fail: Fail	Overall Compliance: No
Severity Score: 21.25			
Codes/Mitigation Info/Possible Solution		Field Measurements/Component Compliance

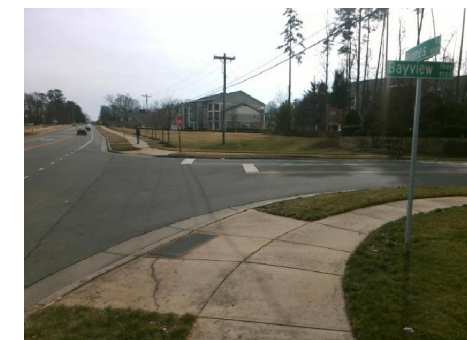
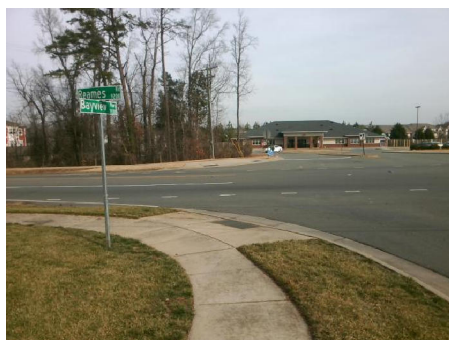
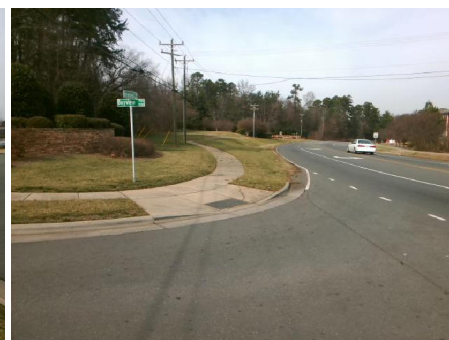
Compliance	Description	Data	Compliance	Description	Data
N/A	Ramp Length (in)	71.0	No	Ramp Slope (%)	8.7
No	Ramp Width (in)	45.5	Yes	Ramp XSlope (%)	1.2
N/A	Flare Type LT	N/A	N/A	Flare Type RT	N/A
N/A	Flare Slope LT (%)	N/A	N/A	Flare Slope RT (%)	N/A
N/A	Flare Traversable LT?	N/A	N/A	Flare Traversable RT?	N/A
N/A	Landing Length (in)	N/A	N/A	DWS Provided?	N/A
N/A	Landing Width (in)	N/A	N/A	DWS Contrast?	N/A
N/A	Landing Slope (%)	N/A	N/A	DWS Length (in)	N/A
N/A	Landing X Slope (%)	N/A	N/A	DWS Full Width?	N/A
N/A	Landing Curb? (Y/N)	N/A	N/A	DWS Offset (in)	N/A
N/A	Shared Landing?	N/A			
N/A	Gutter Ponding?	N/A	N/A	Gutter Slope (%)	N/A
N/A	Gutter Lip Ht (in)	N/A	N/A	Gutter X Slope (%)	N/A
N/A	Painted X Walk1?	No	N/A	Painted X Walk2?	No
	X Walk 1 Direction	To S		X Walk 2 Direction	To N
N/A	X Walk 1 Width (in)	N/A	N/A	X Walk 2 Width (in)	N/A
	X Walk 1 Slope (%)	4.9		X Walk 2 Slope (%)	1.2
	X Walk 1 X Slope (%)	1.7		X Walk 2 X Slope (%)	3.7

N/A	Ramp inside XWalk1?	N/A	N/A	Ramp inside XWalk2?	N/A
	Road Slope (%)	4.1	N/A	Clear Space?	N/A
	Road X Slope (%)	4.3	N/A	Clear Space to XWalk (in)	N/A
N/A	Any Obstructions?	N/A	N/A	Storm Grate/Utility Hazard?	N/A
	Obstruction Type			Storm Grate/Utility Type	
		N/A			N/A
		Yes		Surface Condition? (G/P)	Good

Remove & Replace Curb Ramp With Two New Directional Ramps or Equivalent.
