Access Compliance Report

Public Rights-of-Way

(Curb Ramps)

Intersection ID: N/A	Main Street: PERIMETER_POINTE_PY	Cross Street: GLEN_LAKE_DR	Location: SE
ADA ID: C3EB3EBB13C9	Ramp Type: Perp	Initial Pass/Fail: Fail	Overall Compliance: No
Severity Score: 13.75			
Codes/Mitigation Info/Possible Solution		Field Measurements/Component Compliance

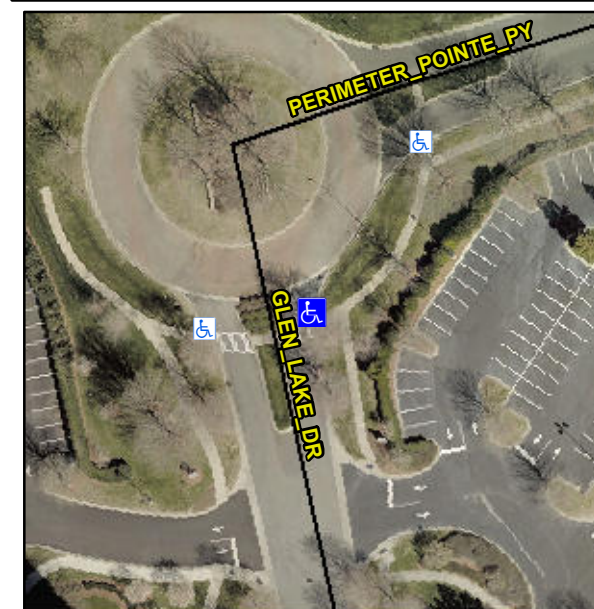
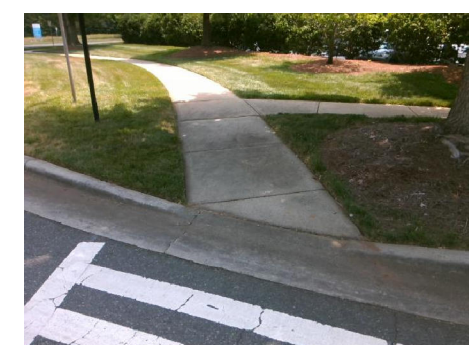
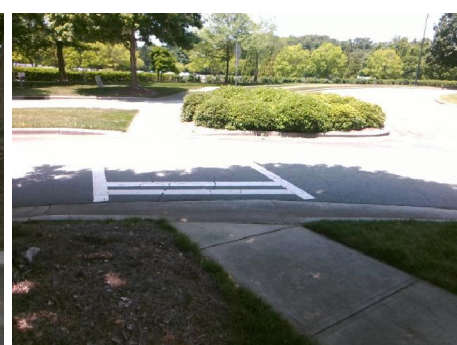
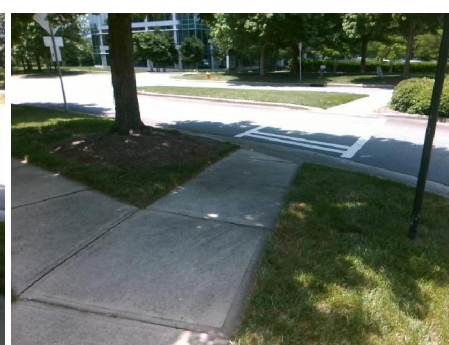
R304.2.2, R304.5.3

Compliance	Description	Data	Compliance	Description	Data
N/A	Ramp Length (in)	127.0	No	Ramp Slope (%)	11.1
Yes	Ramp Width (in)	59.0	No	Ramp XSlope (%)	2.3
N/A	Flare Type LT	N/A	N/A	Flare Type RT	N/A
N/A	Flare Slope LT (%)	N/A	N/A	Flare Slope RT (%)	N/A
N/A	Flare Traversable LT?	N/A	N/A	Flare Traversable RT?	N/A
N/A	Landing Length (in)	N/A	N/A	DWS Provided?	N/A
N/A	Landing Width (in)	N/A	N/A	DWS Contrast?	N/A
N/A	Landing Slope (%)	N/A	N/A	DWS Length (in)	N/A
N/A	Landing X Slope (%)	N/A	N/A	DWS Full Width?	N/A
N/A	Landing Curb? (Y/N)	N/A	N/A	DWS Offset (in)	N/A
N/A	Shared Landing?	N/A			
N/A	Gutter Ponding?	N/A	N/A	Gutter Slope (%)	N/A
N/A	Gutter Lip Ht (in)	N/A	N/A	Gutter X Slope (%)	N/A
N/A	Painted X Walk1?	Yes	N/A	Painted X Walk2?	N/A
	X Walk 1 Direction	To W		X Walk 2 Direction	N/A
N/A	X Walk 1 Width (in)	105.0	N/A	X Walk 2 Width (in)	N/A
	X Walk 1 Slope (%)	2.5		X Walk 2 Slope (%)	N/A
	X Walk 1 X Slope (%)	2.7		X Walk 2 X Slope (%)	N/A

N/A	Ramp inside XWalk1?	Yes	N/A	Ramp inside XWalk2?	N/A
	Road Slope (%)	N/A	N/A	Clear Space?	N/A
	Road X Slope (%)	N/A	N/A	Clear Space to XWalk (in)	N/A
N/A	Any Obstructions?	N/A	N/A	Storm Grate/Utility Hazard?	N/A
	Obstruction Type			Storm Grate/Utility Type	
		N/A			N/A
			Yes	Surface Condition? (G/P)	Good

Remove & Replace Entire Ramp.
