# Access Compliance Report

## Public Rights-of-Way

### (Curb Ramps)

| Intersection ID: 53971 | Main Street: BEREWICK_TOWN_CENTRE | Cross Street: CADEN_RD | Location: E |

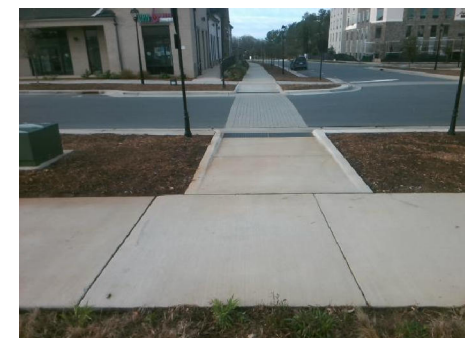
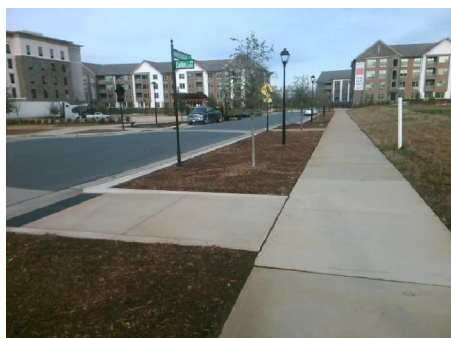
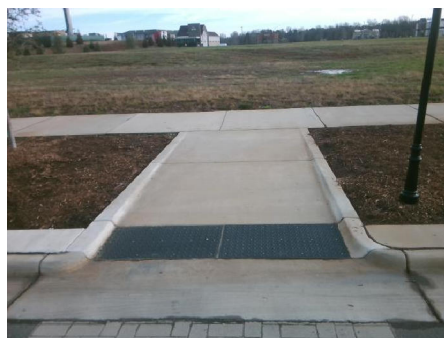
| ADA ID: C3FF37237E1C | Ramp Type: BlendTrans1 | Initial Pass/Fail: Pass | Overall Compliance: No |

| Compliance | Description | Data | Compliance | Description | Data |
|---|---|---|---|---|---|
| | | | No | Curb Slope (%) | 8.0 |

**Remove & Replace Curb Slope and Extend Ramp.**

Total Cost: \$ 2000.00
