Access Compliance Report

Public Rights-of-Way

(Curb Ramps)

Intersection ID: 16072	Main Street: MONROE_RD	Cross Street: RICHLAND_DR	Location: NE
ADA ID: C400FE5CFC55	Ramp Type: Perp	Initial Pass/Fail: Fail	Overall Compliance: No
Severity Score: 8.75			
Codes/Mitigation Info/Possible Solution		Field Measurements/Component Compliance

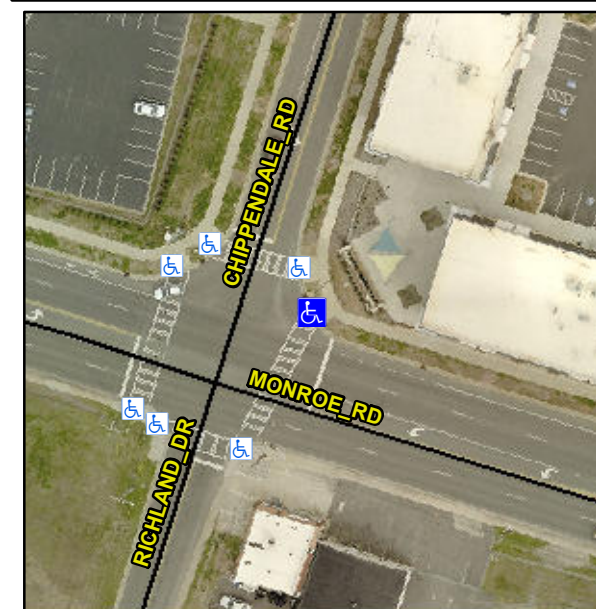
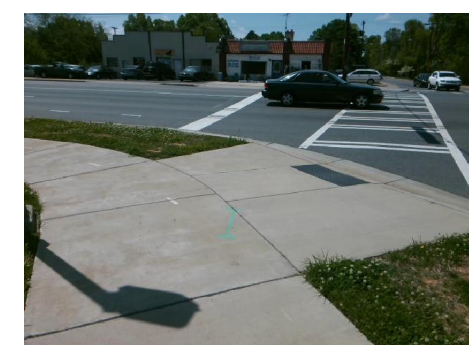
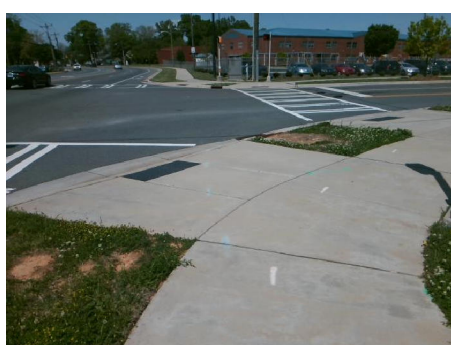
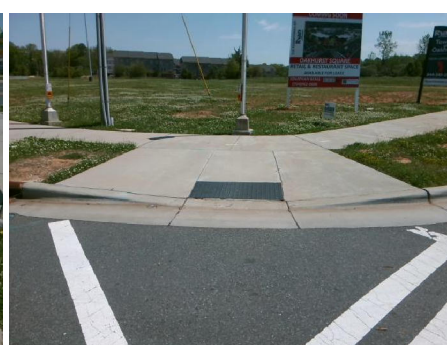
Not Found, R304.5.1

Compliance	Description	Data	Compliance	Description	Data
N/A	Ramp Length (in)	96.0	Yes	Ramp Slope (%)	6.5
No	Ramp Width (in)	44.0	Yes	Ramp XSlope (%)	0.5
N/A	Flare Type LT	N/A	N/A	Flare Type RT	N/A
N/A	Flare Slope LT (%)	N/A	N/A	Flare Slope RT (%)	N/A
N/A	Flare Traversable LT?	N/A	N/A	Flare Traversable RT?	N/A
N/A	Landing Length (in)	N/A	N/A	DWS Provided?	N/A
N/A	Landing Width (in)	N/A	N/A	DWS Contrast?	N/A
N/A	Landing Slope (%)	N/A	N/A	DWS Length (in)	N/A
N/A	Landing X Slope (%)	N/A	N/A	DWS Full Width?	N/A
N/A	Landing Curb? (Y/N)	N/A	N/A	DWS Offset (in)	N/A
N/A	Shared Landing?	N/A			
N/A	Gutter Ponding?	N/A	N/A	Gutter Slope (%)	N/A
N/A	Gutter Lip Ht (in)	N/A	N/A	Gutter X Slope (%)	N/A
N/A	Painted X Walk1?	Yes	N/A	Painted X Walk2?	N/A
	X Walk 1 Direction	To SW		X Walk 2 Direction	N/A
N/A	X Walk 1 Width (in)	114.0	N/A	X Walk 2 Width (in)	N/A
	X Walk 1 Slope (%)	2.1		X Walk 2 Slope (%)	N/A
	X Walk 1 X Slope (%)	1.1		X Walk 2 X Slope (%)	N/A

N/A	Ramp inside XWalk1?	Yes	N/A	Ramp inside XWalk2?	N/A
	Road Slope (%)	N/A	N/A	Clear Space?	N/A
	Road X Slope (%)	N/A	N/A	Clear Space to XWalk (in)	N/A
N/A	Any Obstructions?	N/A	N/A	Storm Grate/Utility Hazard?	N/A
	Obstruction Type			Storm Grate/Utility Type	
		N/A			N/A
		Yes		Surface Condition? (G/P)	Good

Possible Solutions:

Remove & Replace Entire Ramp.
