Access Compliance Report

Public Rights-of-Way

(Curb Ramps)

Intersection ID: 32285	Main Street: ALLYSON_PARK_DR	Cross Street: AUBURN_TOP_LN	Location: SE
ADA ID: C404D381D618	Ramp Type: PerpDiag	Initial Pass/Fail: Fail	Overall Compliance: No
Codes/Mitigation Info/Possible Solution		Field Measurements/Component Compliance	
Severity Score: 33.75

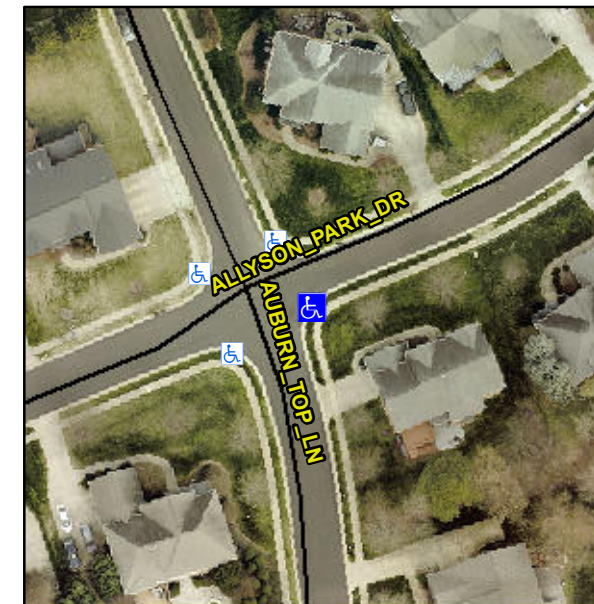
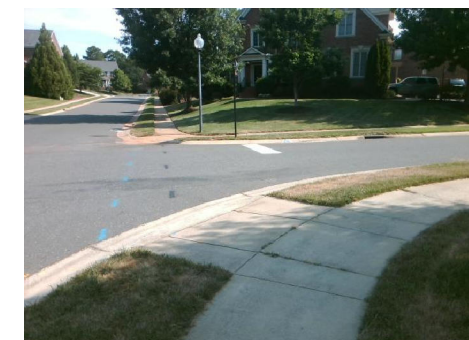
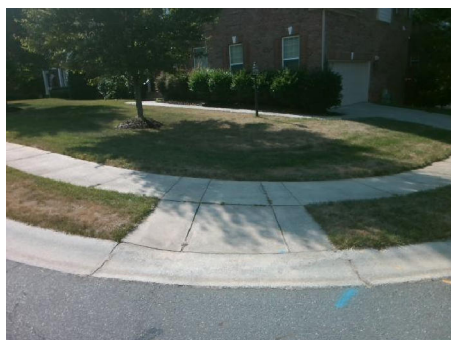
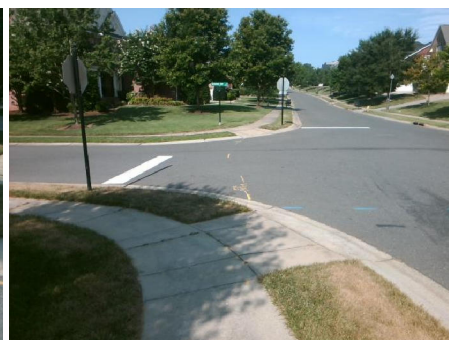
Not Found, R304.5.1, R304.2.2, R304.5.3

Compliance	Description	Data	Compliance	Description	Data
N/A	Ramp Length (in)	51.0	No	Ramp Slope (%)	9.2
No	Ramp Width (in)	41.0	No	Ramp XSlope (%)	6.1
N/A	Flare Type LT	N/A	N/A	Flare Type RT	N/A
N/A	Flare Slope LT (%)	N/A	N/A	Flare Slope RT (%)	N/A
N/A	Flare Traversable LT?	N/A	N/A	Flare Traversable RT?	N/A
N/A	Landing Length (in)	N/A	N/A	DWS Provided?	N/A
N/A	Landing Width (in)	N/A	N/A	DWS Contrast?	N/A
N/A	Landing Slope (%)	N/A	N/A	DWS Length (in)	N/A
N/A	Landing X Slope (%)	N/A	N/A	DWS Full Width?	N/A
N/A	Landing Curb? (Y/N)	N/A	N/A	DWS Offset (in)	N/A
N/A	Shared Landing?	N/A			
N/A	Gutter Ponding?	N/A	N/A	Gutter Slope (%)	N/A
N/A	Gutter Lip Ht (in)	N/A	N/A	Gutter X Slope (%)	N/A
N/A	Painted X Walk1?	No	N/A	Painted X Walk2?	No
	X Walk 1 Direction	To N		X Walk 2 Direction	To W
N/A	X Walk 1 Width (in)	N/A	N/A	X Walk 2 Width (in)	N/A
	X Walk 1 Slope (%)	5.8		X Walk 2 Slope (%)	0.7
	X Walk 1 X Slope (%)	3.8		X Walk 2 X Slope (%)	4.9

N/A	Ramp inside XWalk1?	N/A	N/A	Ramp inside XWalk2?	N/A
	Road Slope (%)	4.5	N/A	Clear Space?	N/A
	Road X Slope (%)	1.0	N/A	Clear Space to XWalk (in)	N/A
N/A	Any Obstructions?	N/A	N/A	Storm Grate/Utility Hazard?	N/A
	Obstruction Type			Storm Grate/Utility Type	
		N/A			N/A
			Yes	Surface Condition? (G/P)	Good

Possible Solutions:

Remove & Replace Curb Ramp With Two New Directional Ramps or Equivalent.
