Access Compliance Report

Public Rights-of-Way

(Curb Ramps)

Intersection ID: 7758	Main Street: EAGLE_PEAK_DR	Cross Street: GLENMOOR_DR	Location: E
ADA ID: C40E68EC8881	Ramp Type: BlendTrans1	Initial Pass/Fail: Fail	Overall Compliance: No
		Severity Score: 10

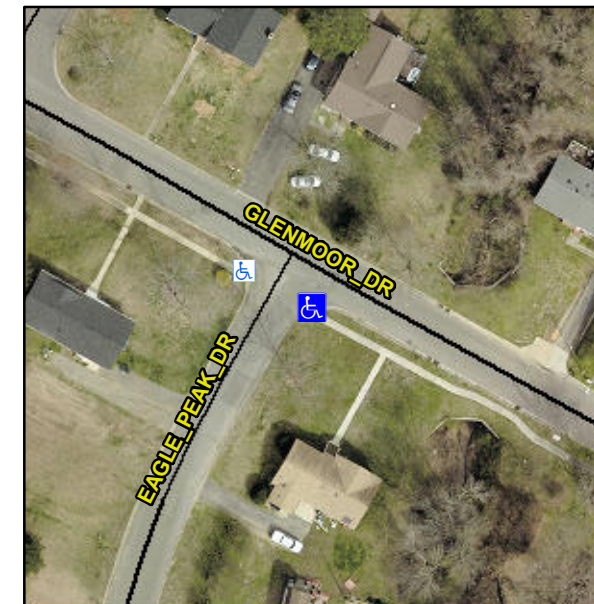
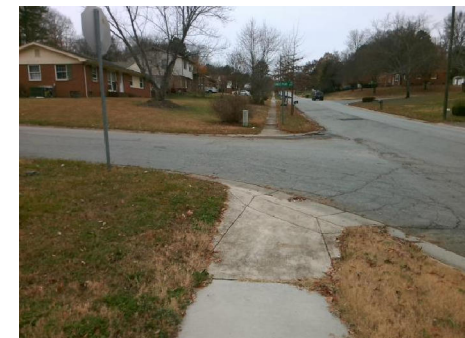
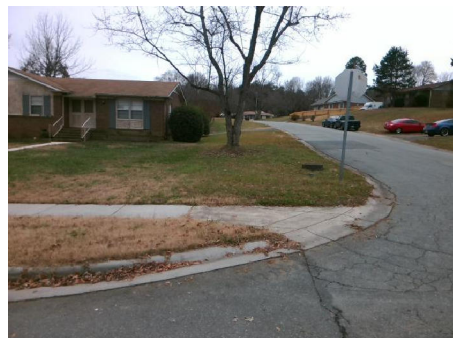
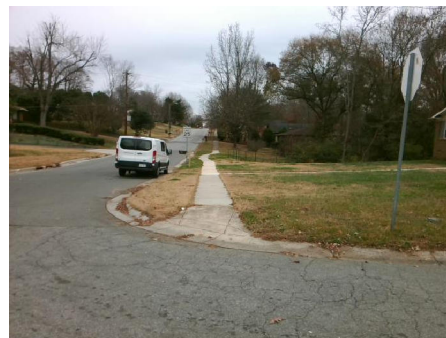
R304.5.1, R304.5.3

Compliance	Description	Data	Compliance	Description	Data
N/A	Ramp Length (in)	75.0	Yes	BlendTrans Slope (%)	0.1
No	Ramp Width (in)	42.0	No	BlendTrans XSlope (%)	4.3
N/A	Flare Type LT	N/A	N/A	Flare Type RT	N/A
N/A	Flare Slope LT (%)	N/A	N/A	Flare Slope RT (%)	N/A
N/A	Flare Traversable LT?	N/A	N/A	Flare Traversable RT?	N/A
N/A	Landing Length (in)	N/A	N/A	DWS Provided?	N/A
N/A	Landing Width (in)	N/A	N/A	DWS Contrast?	N/A
N/A	Landing Slope (%)	N/A	N/A	DWS Length (in)	N/A
N/A	Landing X Slope (%)	N/A	N/A	DWS Full Width?	N/A
N/A	Landing Curb? (Y/N)	N/A	N/A	DWS Offset (in)	N/A
N/A	Shared Landing?	N/A			
N/A	Gutter Ponding?	N/A	N/A	Gutter Slope (%)	N/A
N/A	Gutter Lip Ht (in)	N/A	N/A	Gutter X Slope (%)	N/A
N/A	Painted X Walk1?	No	N/A	Painted X Walk2?	N/A
	X Walk 1 Direction	To NW		X Walk 2 Direction	N/A
	X Walk 1 Width (in)	N/A		X Walk 2 Width (in)	N/A
	X Walk 1 Slope (%)	3.7		X Walk 2 Slope (%)	N/A
	X Walk 1 X Slope (%)	2.0		X Walk 2 X Slope (%)	N/A

N/A	Ramp inside XWalk1?	N/A	N/A	Ramp inside XWalk2?	N/A
	Road Slope (%)	2.0		Clear Space?	N/A
	Road X Slope (%)	3.7	N/A	Clear Space to XWalk (in)	N/A
N/A	Any Obstructions?	N/A	N/A	Storm Grate/Utility Hazard?	N/A
	Obstruction Type			Storm Grate/Utility Type	
		N/A			N/A
			Yes	Surface Condition? (G/P)	Good
			N/A	Curb Slope (%)	3.8

Remove & Replace Curb Ramp With Two New Directional Ramps or Equivalent.
