Access Compliance Report

Public Rights-of-Way

(Curb Ramps)

Intersection ID: 25705	Main Street: REA_RD	Cross Street: SUNDANCER_LN	Location: SW
ADA ID: C4110791A270	Ramp Type: Directional1	Initial Pass/Fail: Fail	Overall Compliance: No
			Severity Score: 13.75

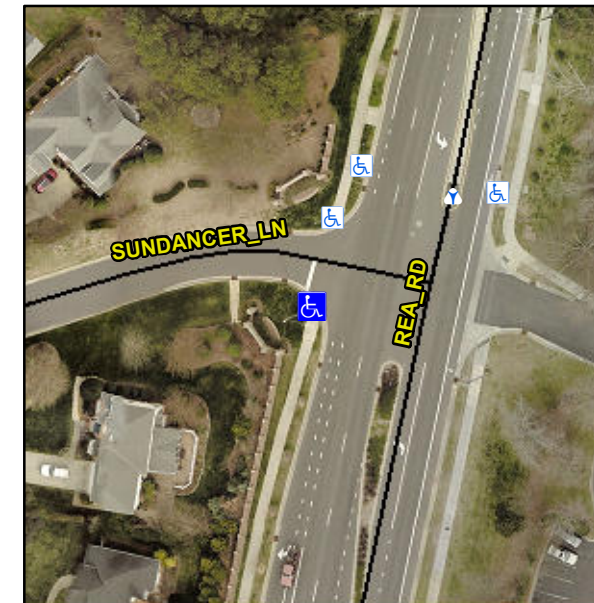
Compliance	Description	Data	Compliance	Description	Data
N/A	Ramp Length (in)	183.0	N/A	Grade Break?	N/A
Yes	Ramp Width (in)	64.0	N/A	Grade Break Slope (%)	0.0
Yes	Ramp Slope (%)	8.7	N/A	Grade Break XSlope (%)	0.0
No	Ramp XSlope (%)	2.7			
N/A	Flare Type LT	N/A	N/A	Flare Type RT	N/A
N/A	Flare Slope LT (%)	N/A	N/A	Flare Slope RT (%)	0.0
N/A	Flare Traversable LT?	N/A	N/A	Flare Traversable RT?	N/A
N/A	Landing Length (in)	0.0	N/A	DWS Provided?	N/A
N/A	Landing Width (in)	0.0	N/A	DWS Contrast?	N/A
N/A	Landing Slope (%)	0.0	N/A	DWS Length (in)	N/A
N/A	Landing X Slope (%)	0.0	N/A	DWS Full Width?	N/A
N/A	Landing Curb? (Y/N)	N/A	N/A	DWS Offset LT (in)	N/A
N/A	Shared Landing?	N/A	N/A	DWS Offset RT (in)	N/A
N/A	Gutter Ponding?	0.0	N/A	Gutter Slope (%)	N/A
N/A	Gutter Lip Ht (in)	0.0	N/A	Gutter X Slope (%)	N/A
N/A	Painted X Walk1?	No		Road Slope (%)	4.9
	X Walk 1 Direction	To N		Road X Slope (%)	0.1
	X Walk 1 Width (in)	N/A		Clear Space?	N/A

X Walk 1 Slope (%)	4.9	N/A	Clear Space to XWalk (in)	N/A
	X Walk 1 X Slope (%)	0.1	N/A	Storm Grate/Utility Hazard?	N/A
N/A	Ramp inside XWalk1?	N/A		Storm Grate/Utility Type	
N/A	Any Obstructions?	N/A			N/A
	Obstruction Type		Yes	Surface Condition? (G/P)	Good
			N/A	Curb Slope (%)	1.5

Remove & Replace Entire Ramp.

Total Cost: \$ 1600.00
