## **Access Compliance Report Public Rights-of-Way** (Curb Ramps)

Intersection ID: 53130 Main Street: CAMPANA\_LN **Cross Street: VERNET LN** Location: **Overall Compliance: No** ADA ID: C4343118F397 Ramp Type: BlendTrans1 Initial Pass/Fail: Fail **Severity Score:** 35

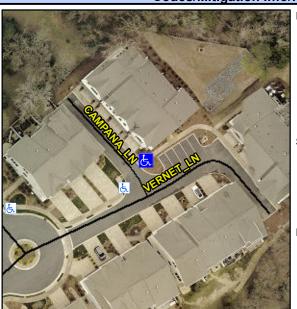
Compliance Description Da		Data	Compliance Description		Data
N/A	Ramp Length (in)	32.0	Yes	BlendTrans Slope (%)	0.7
No	Ramp Width (in)	28.0	Yes	BlendTrans XSlope (%)	1.6
N/A	Flare Type LT	N/A	N/A	Flare Type RT	N/A
N/A	Flare Slope LT (%)	N/A	N/A	Flare Slope RT (%)	N/A
N/A	Flare Traversable LT?	N/A	N/A	Flare Traversable RT?	N/A
N/A	Landing Length (in)	N/A	N/A	DWS Provided?	N/A
N/A	Landing Width (in)	N/A	N/A	DWS Contrast?	N/A
N/A	Landing Slope (%)	N/A	N/A	DWS Length (in)	N/A
N/A	Landing X Slope (%)	N/A	N/A	DWS Full Width?	N/A
N/A	Landing Curb? (Y/N)	N/A	N/A	DWS Offset (in)	N/A
N/A	Shared Landing?	N/A			
N/A	Gutter Ponding?	N/A	N/A	Gutter Slope (%)	N/A
N/A	Gutter Lip Ht (in)	N/A	N/A	Gutter X Slope (%)	N/A
N/A	Painted X Walk1?	No	N/A	Painted X Walk2?	N/A
	X Walk 1 Direction	To SW		X Walk 2 Direction	N/A
	X Walk 1 Width (in)	N/A		X Walk 2 Width (in)	N/A
	X Walk 1 Slope (%)	0.6		X Walk 2 Slope (%)	N/A
	X Walk 1 X Slope (%)	0.7		X Walk 2 X Slope (%)	N/A

N/A	Ramp inside XWalk1?	N/A	N/A	Ramp inside XWalk2?	N/A
	Road Slope (%)	0.7		Clear Space?	N/A
	Road X Slope (%)	0.6	N/A	Clear Space to XWalk (in)	N/A
N/A	Any Obstructions?	N/A	N/A	Storm Grate/Utility Hazard?	N/A
	Obstruction Type		l	Storm Grate/Utility Type	
		N/A	l		N/A
			Yes	Surface Condition? (G/P)	Good

Possible Solutions: Remove & Replace Curb Ramp With Two New Directional Ramps or Equivalent. Surveyor Notes: N/A PROW/ADA: R304.5.1

Total Cost: 3200.00
