# Access Compliance Report

## Public Rights-of-Way

### (Curb Ramps)

| ADA ID: C4364D5C778D | Ramp Type: MedianPerp | Initial Pass/Fail: Pass | Overall Compliance: No |

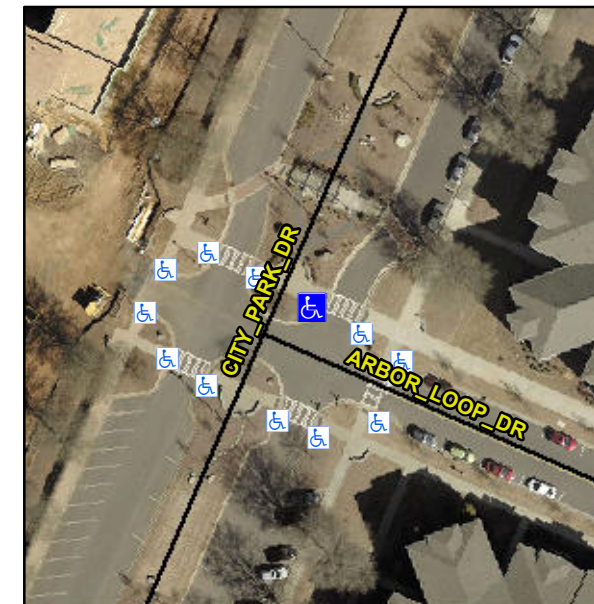
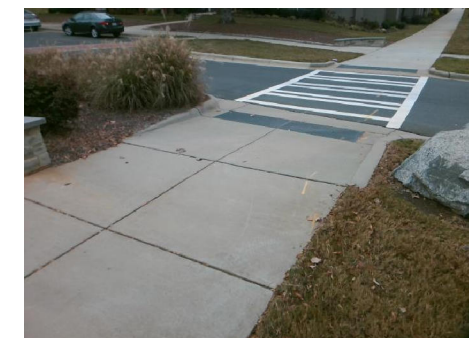
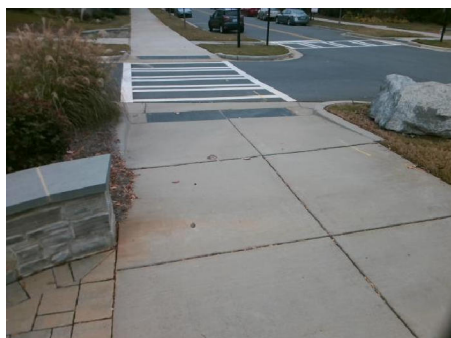
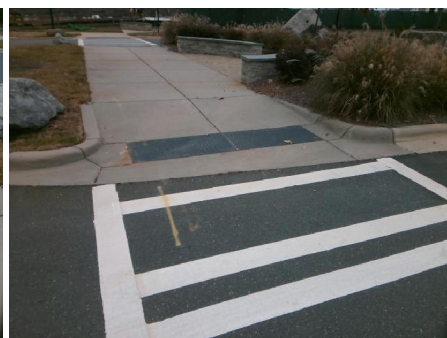
| Compliance | Description | Data | Compliance | Description | Data |
|---|---|---|---|---|---|
| Yes | Landing X Slope (%) | 0.8 | No | DWS Full Width? | No |
| Yes | Gutter Lip Ht (in) | 0.0 | No | Gutter X Slope (%) | 3.1 |

**Remove & Replace Detectable Warning System. Remove & Replace Gutter.**

**R305.1.4, R304.5.3**
