Access Compliance Report

Public Rights-of-Way

(Curb Ramps)

Intersection ID: 15489	Main Street: HARVARD_PL	Cross Street: QUEENS_RD	Location: NE
ADA ID: C438341D45EE	Ramp Type: Perp	Initial Pass/Fail: Fail	Overall Compliance: No
Severity Score: 50			
Codes/Mitigation Info/Possible Solution		Field Measurements/Component Compliance

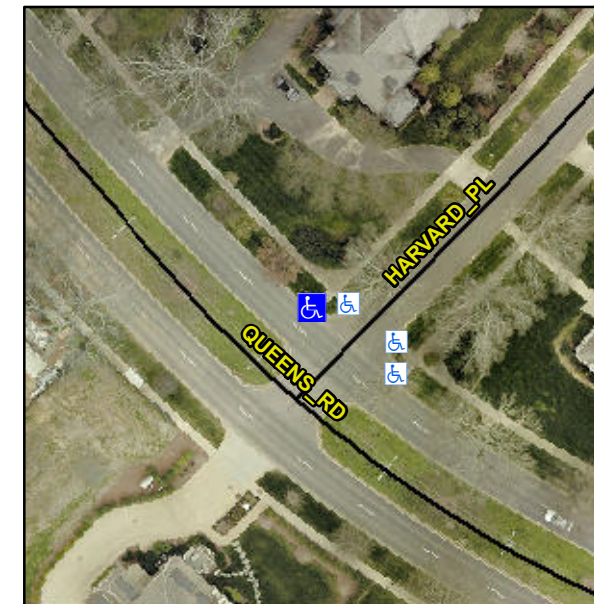
R304.2.2, R304.5.3

Compliance	Description	Data	Compliance	Description	Data
N/A	Ramp Length (in)	101.0	No	Ramp Slope (%)	12.8
Yes	Ramp Width (in)	55.0	No	Ramp XSlope (%)	8.9
N/A	Flare Type LT	N/A	N/A	Flare Type RT	N/A
N/A	Flare Slope LT (%)	N/A	N/A	Flare Slope RT (%)	N/A
N/A	Flare Traversable LT?	N/A	N/A	Flare Traversable RT?	N/A
N/A	Landing Length (in)	N/A	N/A	DWS Provided?	N/A
N/A	Landing Width (in)	N/A	N/A	DWS Contrast?	N/A
N/A	Landing Slope (%)	N/A	N/A	DWS Length (in)	N/A
N/A	Landing X Slope (%)	N/A	N/A	DWS Full Width?	N/A
N/A	Landing Curb? (Y/N)	N/A	N/A	DWS Offset (in)	N/A
N/A	Shared Landing?	N/A			
N/A	Gutter Ponding?	N/A	N/A	Gutter Slope (%)	N/A
N/A	Gutter Lip Ht (in)	N/A	N/A	Gutter X Slope (%)	N/A
N/A	Painted X Walk1?	No	N/A	Painted X Walk2?	N/A
	X Walk 1 Direction	To SW		X Walk 2 Direction	N/A
N/A	X Walk 1 Width (in)	N/A	N/A	X Walk 2 Width (in)	N/A
	X Walk 1 Slope (%)	4.5		X Walk 2 Slope (%)	N/A
	X Walk 1 X Slope (%)	0.5		X Walk 2 X Slope (%)	N/A

Remove & Replace Entire Ramp.
