# Access Compliance Report

## Public Rights-of-Way

### (Curb Ramps)

| Intersection ID: 10037289 | Main Street: SARDIS_RD_NORTH | Cross Street: N/A | Location: SW |

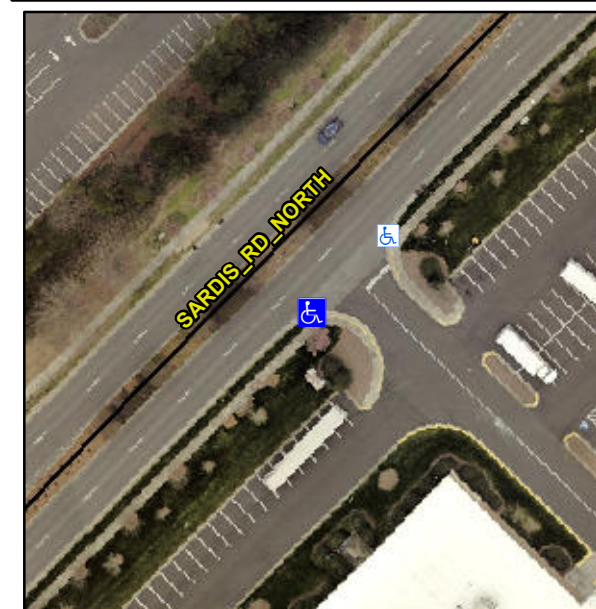
**Not Found, R304.5.1, R304.2.2, R304.5.3**

| Compliance | Description | Data | Compliance | Description | Data |
|---|---|---|---|---|---|
| N/A | Ramp Length (in) | 64.0 | No | Ramp Slope (%) | 9.8 |
| No | Ramp Width (in) | 33.0 | No | Ramp XSlope (%) | 7.4 |

**Remove & Replace Entire Ramp.**
