# Access Compliance Report

## Public Rights-of-Way

### (Curb Ramps)

Intersection ID: 52521	Main Street: LORNA_ST	Cross Street: MCCLINTOCK_RD	Location: NW
ADA ID: C441C7A41D6A	Ramp Type: Perp	Initial Pass/Fail: Pass	Overall Compliance: No
		Severity Score: 0

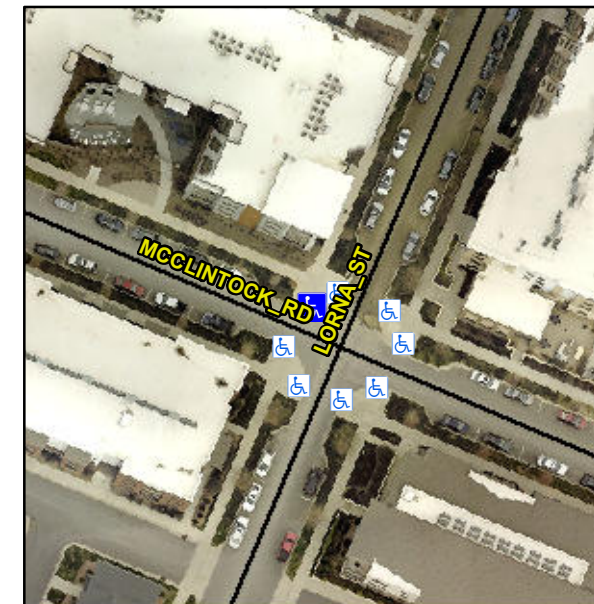
Compliance	Description	Data	Compliance	Description	Data
N/A	Ramp Length (in)	140.0	Yes	Ramp Slope (%)	5.3
Yes	Ramp Width (in)	50.0	Yes	Ramp XSlope (%)	0.9
N/A	Flare Type LT	Sloped	N/A	Flare Type RT	N/A
N/A	Flare Slope LT (%)	7.5	Yes	Flare Slope RT (%)	5.7
N/A	Flare Traversable LT?	No	N/A	Flare Traversable RT?	Yes
Yes	Landing Length (in)	72.0	Yes	DWS Provided?	Yes
Yes	Landing Width (in)	72.0	Yes	DWS Contrast?	Yes
Yes	Landing Slope (%)	1.3	Yes	DWS Length (in)	24.0
Yes	Landing X Slope (%)	1.5	Yes	DWS Full Width?	Yes
N/A	Landing Curb? (Y/N)	No	No	DWS Offset (in)	10.0
N/A	Shared Landing?	Yes			
Yes	Gutter Ponding?	No	Yes	Gutter Slope (%)	4.0
Yes	Gutter Lip Ht (in)	0.0	No	Gutter X Slope (%)	2.4
N/A	Painted X Walk1?	No	N/A	Painted X Walk2?	N/A
	X Walk 1 Direction	To S		X Walk 2 Direction	N/A
N/A	X Walk 1 Width (in)	N/A	N/A	X Walk 2 Width (in)	N/A
	X Walk 1 Slope (%)	2.9		X Walk 2 Slope (%)	N/A
	X Walk 1 X Slope (%)	1.7		X Walk 2 X Slope (%)	N/A

N/A	Ramp inside XWalk1?	N/A	N/A	Ramp inside XWalk2?	N/A
	Road Slope (%)	N/A	N/A	Clear Space?	Yes
	Road X Slope (%)	N/A	N/A	Clear Space to XWalk (in)	N/A
Yes	Any Obstructions?	No	Yes	Storm Grate/Utility Hazard?	No
	Obstruction Type			Storm Grate/Utility Type	
		N/A			N/A
			Yes	Surface Condition? (G/P)	Good

Possible Solutions:

**Remove & Replace Detectable Warning System. Remove & Replace Gutter.**

**R305.2, R304.5.3**
